# Access Compliance Report

## Public Rights-of-Way

### (Curb Ramps)

Intersection ID: 10037649	Main Street: SEVENTY_SEVEN_CENTER_DR	Cross Street: N/A	Location: SW
ADA ID: D1100B10D598	Ramp Type: PerpDiag	Initial Pass/Fail: Fail	Overall Compliance: No
		Severity Score: 12.5

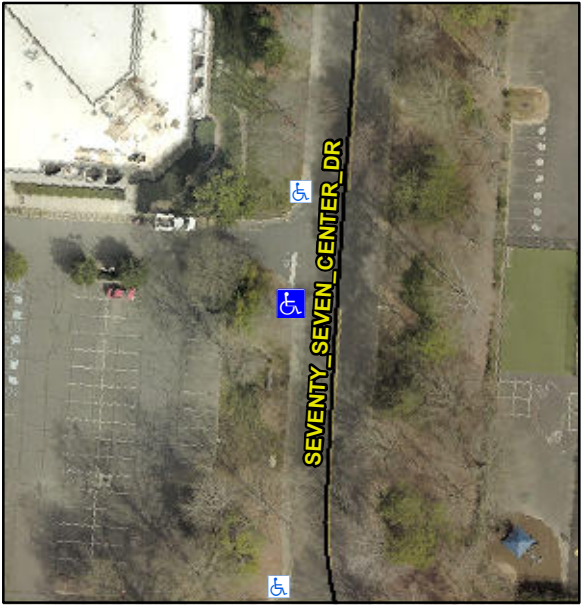
Possible Solutions:		<b>Compliance</b>	<b>Description</b>	<b>Data</b>
	<b>Remove &amp; Replace Curb Ramp With Two New Directional Ramps or Equivalent.</b>		<b>Yes</b>	Ramp Length (in)	<b>47.0</b>
			<b>N/A</b>	Ramp Width (in)	<b>48.0</b>
			<b>N/A</b>	Flare Type LT	<b>N/A</b>
			<b>N/A</b>	Flare Slope LT (%)	<b>N/A</b>
			<b>N/A</b>	Flare Traversable LT?	<b>N/A</b>
			<b>N/A</b>	Landing Length (in)	<b>N/A</b>
			<b>N/A</b>	Landing Width (in)	<b>N/A</b>
			<b>N/A</b>	Landing Slope (%)	<b>N/A</b>
			<b>N/A</b>	Landing X Slope (%)	<b>N/A</b>
<p>Surveyor Notes:</p> <p><b>N/A</b></p> <p>PROW/ADA:</p> <p><b>Not Found, R304.5.3</b></p>			<b>N/A</b>	Flare Type RT	<b>N/A</b>
			<b>N/A</b>	Flare Slope RT (%)	<b>N/A</b>
			<b>N/A</b>	Flare Traversable RT?	<b>N/A</b>
			<b>N/A</b>	DWS Provided?	<b>N/A</b>
			<b>N/A</b>	DWS Contrast?	<b>N/A</b>

<b>N/A</b>	DWS Length (in)	<b>N/A</b>
			<b>N/A</b>	DWS Full Width?	<b>N/A</b>
			<b>N/A</b>	DWS Offset (in)	<b>N/A</b>
			<b>N/A</b>	Gutter Ponding?	<b>N/A</b>
			<b>N/A</b>	Gutter Lip Ht (in)	<b>N/A</b>
<p>Total Cost:</p> <p><b>\$ 3200.00</b></p>			<b>No</b>	Painted X Walk1?	<b>No</b>
			<b>To E</b>	X Walk 2 Direction	<b>To N</b>
			<b>N/A</b>	X Walk 2 Width (in)	<b>N/A</b>
			<b>1.7</b>	X Walk 2 Slope (%)	<b>3.1</b>
			<b>1.5</b>	X Walk 2 X Slope (%)	<b>0.8</b>
			<b>N/A</b>	Ramp inside XWalk2?	<b>N/A</b>
			<b>1.9</b>	Clear Space?	<b>N/A</b>
			<b>3.1</b>	Clear Space to XWalk (in)	<b>N/A</b>
			<b>N/A</b>	Storm Grate/Utility Hazard?	<b>N/A</b>
			<b>N/A</b>	Storm Grate/Utility Type	<b>N/A</b>
			<b>N/A</b>	Surface Condition? (G/P)	<b>Good</b>
