Access Compliance Report Public Rights-of-Way (Curb Ramps)

Intersection ID: 29190Main Street:JADE_GLEN_DRCross Street:BIG_LEAF_DRLocation:NEADA ID: D1124C06B4CDRamp Type:PerpDiagInitial Pass/Fail:FailOverall Compliance:NoSeverity Score:12.5

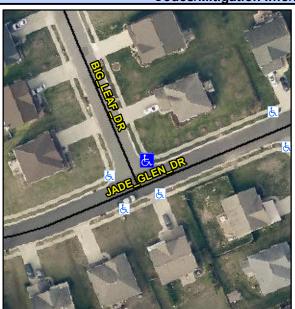
Not Found, R304.5.3

Field Measurements/Component Compliance						
Compliance Description		Data	Comp	liance Description	Data	
ı	N/A	Ramp Length (in)	48.0	Yes	Ramp Slope (%)	5.5
,	Yes	Ramp Width (in)	48.0	No	Ramp XSlope (%)	5.1
1	N/A	Flare Type LT	N/A	N/A	Flare Type RT	N/A
ı	N/A	Flare Slope LT (%)	N/A	N/A	Flare Slope RT (%)	N/A
ı	N/A	Flare Traversable LT?	N/A	N/A	Flare Traversable RT?	N/A
ı	N/A	Landing Length (in)	N/A	N/A	DWS Provided?	N/A
ı	N/A	Landing Width (in)	N/A	N/A	DWS Contrast?	N/A
ı	N/A	Landing Slope (%)	N/A	N/A	DWS Length (in)	N/A
ı	N/A	Landing X Slope (%)	N/A	N/A	DWS Full Width?	N/A
ı	N/A	Landing Curb? (Y/N)	N/A	N/A	DWS Offset (in)	N/A
ı	N/A	Shared Landing?	N/A			
ı	N/A	Gutter Ponding?	N/A	N/A	Gutter Slope (%)	N/A
1	N/A	Gutter Lip Ht (in)	N/A	N/A	Gutter X Slope (%)	N/A
ı	N/A	Painted X Walk1?	No	N/A	Painted X Walk2?	No
		X Walk 1 Direction	To W		X Walk 2 Direction	To S
ı	N/A	X Walk 1 Width (in)	N/A	N/A	X Walk 2 Width (in)	N/A

X Walk 1 Slope (%)	1.4		X Walk 2 Slope (%)	3.5
		X Walk 1 X Slope (%)	2.4		X Walk 2 X Slope (%)	1.1
ı	N/A	Ramp inside XWalk1?	N/A	N/A	Ramp inside XWalk2?	N/A
		Road Slope (%)	2.8	N/A	Clear Space?	N/A
		Road X Slope (%)	2.5	N/A	Clear Space to XWalk (in)	N/A
ı	N/A	Any Obstructions?	N/A	N/A	Storm Grate/Utility Hazard?	N/A
		Obstruction Type			Storm Grate/Utility Type	
			N/A			N/A
				Yes	Surface Condition? (G/P)	Good
married SQ.

Remove & Replace Curb Ramp With
Two New Directional Ramps or
Equivalent.
