Access Compliance Report

Public Rights-of-Way

(Curb Ramps)

| Intersection ID: 29425 | Main Street: BRADSTREET_COMMONS_WY | Cross Street: NOVELLA_DR | Location: W |

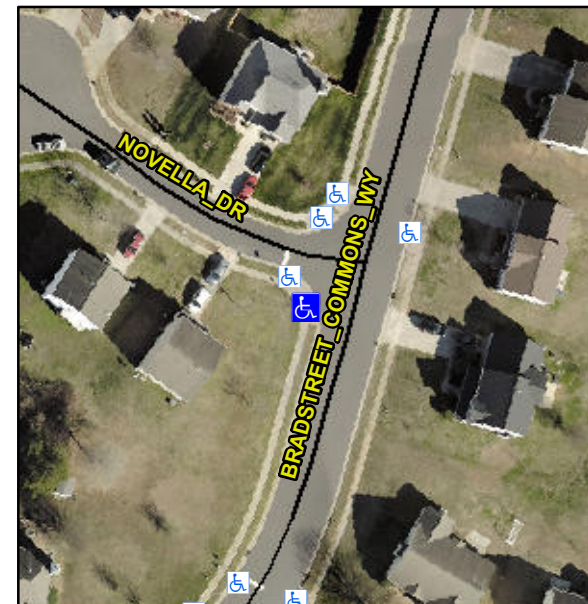
| Severity Score: 21.25 | | | |

Not Found, R304.5.1, R304.2.2

| Compliance | Description | Data | Compliance | Description | Data |
|---|---|---|---|---|---|
| N/A | Ramp Length (in) | 48.0 | No | Ramp Slope (%) | 9.5 |
| No | Ramp Width (in) | 47.0 | Yes | Ramp XSlope (%) | 1.6 |

Remove & Replace Entire Ramp.

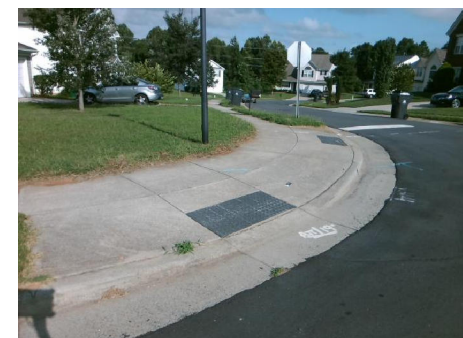
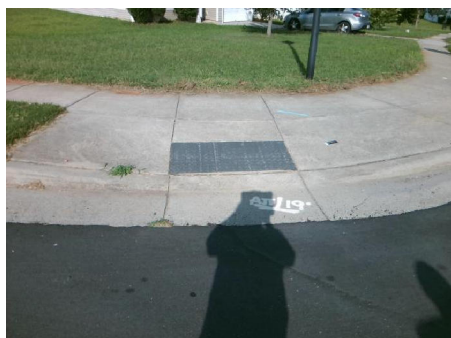
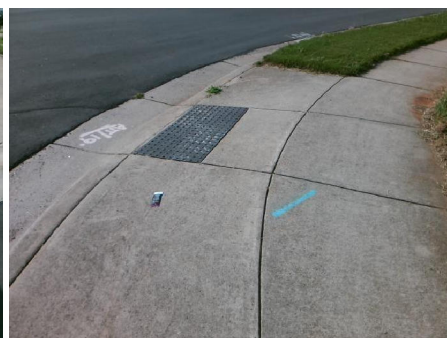
| Compliance | Description | Data | Compliance | Description | Data |
|---|---|---|---|---|---|
| | | | Yes | Surface Condition? (G/P) | Good |
