# Access Compliance Report

## Public Rights-of-Way

| Intersection ID: 6690 | Main Street: NEVIN_RD | Cross Street: SPRING_TERRACE_LN | Location: W |
| ADA ID: D120BD1BB124 | Ramp Type: Directional1 | Initial Pass/Fail: Pass | Overall Compliance: No |

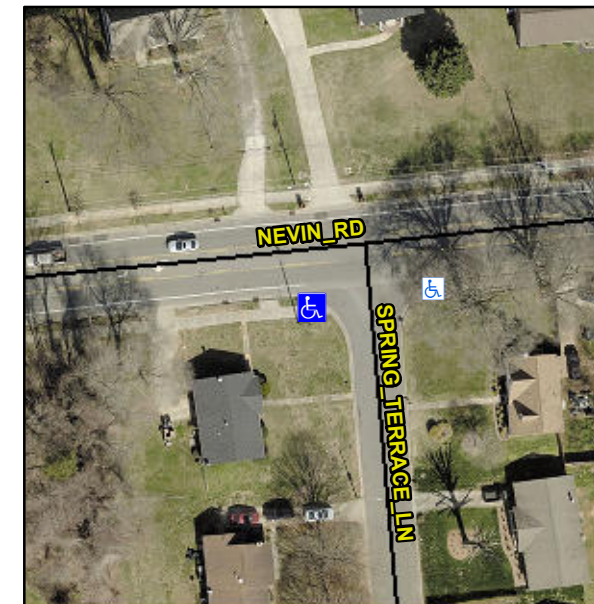
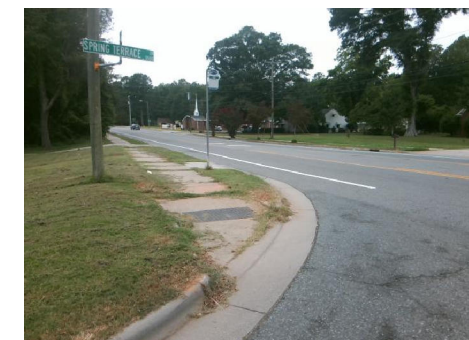
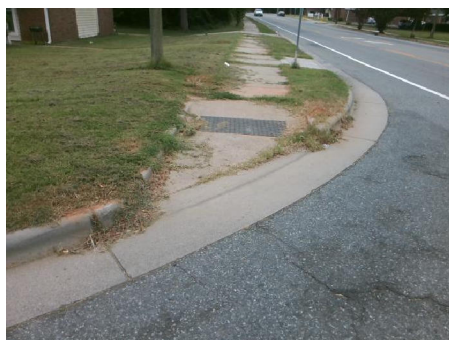
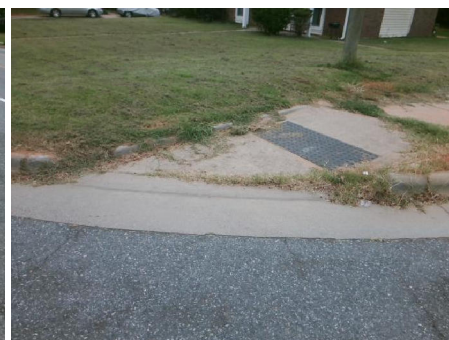
| | | Severity Score: 2.75 | |

**R304.5.3, R305.1.4, R305.2**

| Compliance | Description | Data | Compliance | Description | Data |
|---|---|---|---|---|---|
| Yes | Ramp Width (in) | 68.0 | No | Grade Break Slope (%) | 6.6 |
| No | Ramp XSlope (%) | 2.2 | | | |
| Yes | Landing X Slope (%) | 0.5 | No | DWS Full Width? | No |
| N/A | Shared Landing? | No | No | DWS Offset RT (in) | 9.5 |
| Yes | Gutter Lip Ht (in) | 0.0 | No | Gutter X Slope (%) | 2.6 |

**Remove & Replace Entire Ramp.  
Remove & Replace Gutter.**

Total Cost: \$ 2350.00
