Access Compliance Report

Public Rights-of-Way

(Curb Ramps)

Intersection ID: 27411	Main Street: BALLANTYNE COMMONS PY	Cross Street: BALLANTYNE CORPORATE PL	Location: SW
ADA ID: D1296BE1C16C	Ramp Type: Perp	Initial Pass/Fail: Fail	Overall Compliance: No
Severity Score: 21.25			
Codes/Mitigation Info/Possible Solution		Field Measurements/Component Compliance

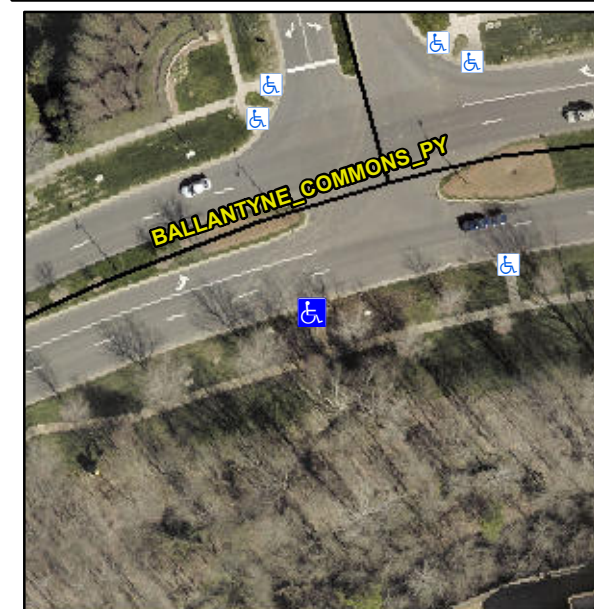
Not Found, R304.5.1, R304.5.3

Compliance	Description	Data	Compliance	Description	Data
N/A	Ramp Length (in)	129.0	Yes	Ramp Slope (%)	5.1
No	Ramp Width (in)	47.0	No	Ramp XSlope (%)	5.1
N/A	Flare Type LT	N/A	N/A	Flare Type RT	N/A
N/A	Flare Slope LT (%)	N/A	N/A	Flare Slope RT (%)	N/A
N/A	Flare Traversable LT?	N/A	N/A	Flare Traversable RT?	N/A
N/A	Landing Length (in)	N/A	N/A	DWS Provided?	N/A
N/A	Landing Width (in)	N/A	N/A	DWS Contrast?	N/A
N/A	Landing Slope (%)	N/A	N/A	DWS Length (in)	N/A
N/A	Landing X Slope (%)	N/A	N/A	DWS Full Width?	N/A
N/A	Landing Curb? (Y/N)	N/A	N/A	DWS Offset (in)	N/A
N/A	Shared Landing?	N/A			
N/A	Gutter Ponding?	N/A	N/A	Gutter Slope (%)	N/A
N/A	Gutter Lip Ht (in)	N/A	N/A	Gutter X Slope (%)	N/A
N/A	Painted X Walk1?	No	N/A	Painted X Walk2?	N/A
	X Walk 1 Direction	To N		X Walk 2 Direction	N/A
N/A	X Walk 1 Width (in)	N/A	N/A	X Walk 2 Width (in)	N/A
	X Walk 1 Slope (%)	4.5		X Walk 2 Slope (%)	N/A
	X Walk 1 X Slope (%)	1.9		X Walk 2 X Slope (%)	N/A

N/A	Ramp inside XWalk1?	N/A	N/A	Ramp inside XWalk2?	N/A
	Road Slope (%)	N/A	N/A	Clear Space?	N/A
	Road X Slope (%)	N/A	N/A	Clear Space to XWalk (in)	N/A
N/A	Any Obstructions?	N/A	N/A	Storm Grate/Utility Hazard?	N/A
	Obstruction Type			Storm Grate/Utility Type	
		N/A			N/A
			Yes	Surface Condition? (G/P)	Good

Possible Solutions:

Remove & Replace Entire Ramp.
