Access Compliance Report

Public Rights-of-Way

(Curb Ramps)

Intersection ID: 19959	Main Street: DEERFIELD_PL	Cross Street: WINTERCREST_LN	Location: S
ADA ID: D12E3A7FE8D1	Ramp Type: Directional1	Initial Pass/Fail: Fail	Overall Compliance: No
		Severity Score: 12.5

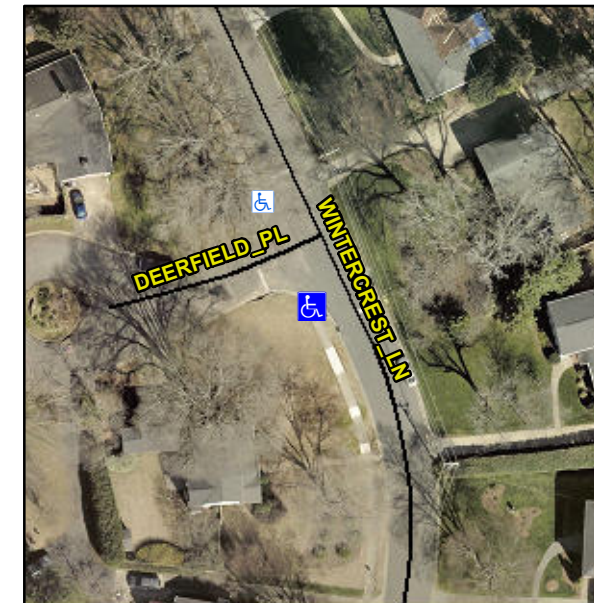
Compliance	Description	Data	Compliance	Description	Data
N/A	Ramp Length (in)	32.0	N/A	Grade Break?	N/A
Yes	Ramp Width (in)	59.0	N/A	Grade Break Slope (%)	0.0
Yes	Ramp Slope (%)	5.8	N/A	Grade Break XSlope (%)	0.0
No	Ramp XSlope (%)	6.2			
N/A	Flare Type LT	N/A	N/A	Flare Type RT	N/A
N/A	Flare Slope LT (%)	N/A	N/A	Flare Slope RT (%)	0.0
N/A	Flare Traversable LT?	N/A	N/A	Flare Traversable RT?	N/A
N/A	Landing Length (in)	0.0	N/A	DWS Provided?	N/A
N/A	Landing Width (in)	0.0	N/A	DWS Contrast?	N/A
N/A	Landing Slope (%)	0.0	N/A	DWS Length (in)	N/A
N/A	Landing X Slope (%)	0.0	N/A	DWS Full Width?	N/A
N/A	Landing Curb? (Y/N)	N/A	N/A	DWS Offset LT (in)	N/A
N/A	Shared Landing?	N/A	N/A	DWS Offset RT (in)	N/A
N/A	Gutter Ponding?	0.0	N/A	Gutter Slope (%)	N/A
N/A	Gutter Lip Ht (in)	0.0	N/A	Gutter X Slope (%)	N/A
N/A	Painted X Walk1?	No		Road Slope (%)	0.9
	X Walk 1 Direction	To NW		Road X Slope (%)	2.5
	X Walk 1 Width (in)	N/A		Clear Space?	N/A

X Walk 1 Slope (%)	0.9	N/A	Clear Space to XWalk (in)	N/A
	X Walk 1 X Slope (%)	2.5	N/A	Storm Grate/Utility Hazard?	N/A
N/A	Ramp inside XWalk1?	N/A		Storm Grate/Utility Type	
N/A	Any Obstructions?	N/A			N/A
	Obstruction Type		Yes	Surface Condition? (G/P)	Good
			N/A	Curb Slope (%)	2.3

Remove & Replace Entire Ramp.
