Access Compliance Report

Public Rights-of-Way

(Curb Ramps)

| Intersection ID: 10025333 | Main Street: E_6TH_ST | Cross Street: N/A | Location: | N |

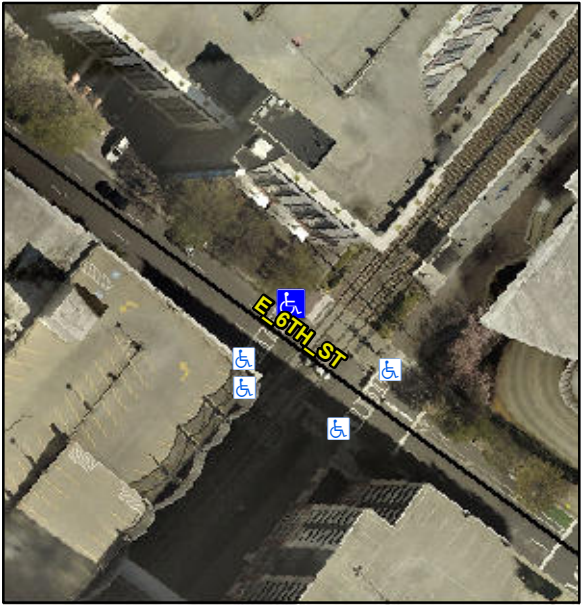
| ADA ID: D14C5DD18228 | Ramp Type: Perp | Initial Pass/Fail: Pass | Overall Compliance: No | Severity Score: 0 |

| Codes/Mitigation Info/Possible Solution | | Field Measurements/Component Compliance | | | | | |
|---|---|---|---|---|---|---|---|
| | Surveyor Notes: | N/A | | | | | |
| | | N/A | Ramp Length (in) | 38.0 | Yes | Ramp Slope (%) | 2.2 |
| | | Yes | Ramp Width (in) | 48.0 | Yes | Ramp XSlope (%) | 0.4 |
| | | N/A | Flare Slope LT (%) | 8.4 | Yes | Flare Slope RT (%) | 2.4 |
| | | Yes | Gutter Ponding? | No | Yes | Gutter Slope (%) | 2.6 |
| | | | | | Yes | Surface Condition? (G/P) | Good |

| Codes/Mitigation Info/Possible Solution | | Field Measurements/Component Compliance | | | | | |
|---|---|---|---|---|---|---|---|
| | Possible Solutions: | Remove & Replace Entire Ramp. | | | | | |
| | Total Cost: | \$ 1850.00 | | | | | |

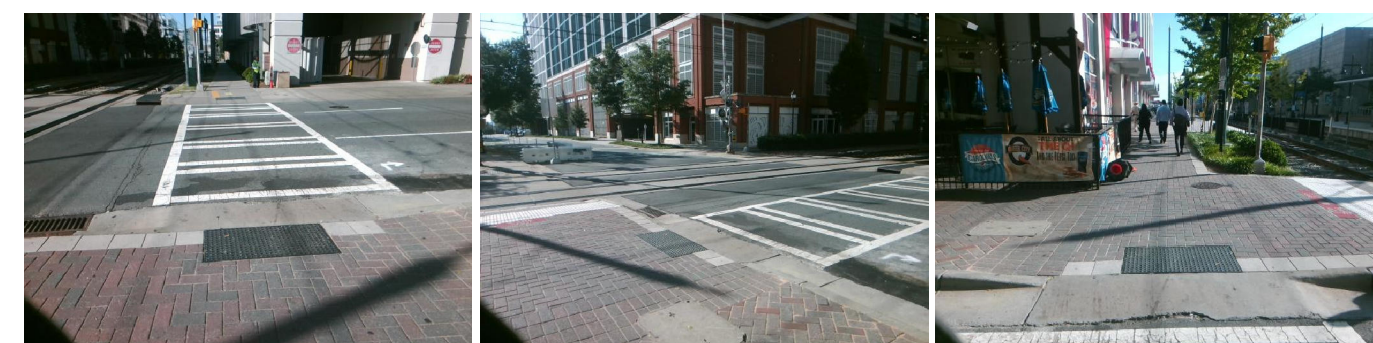
| Codes/Mitigation Info/Possible Solution | | Field Measurements/Component Compliance | | | | | |
|---|---|---|---|---|---|---|---|
| | | Yes | Landing Length (in) | 48.0 | Yes | DWS Provided? | Yes |
| | | Yes | Landing Width (in) | 48.0 | Yes | DWS Contrast? | Yes |
| | | Yes | Landing Slope (%) | 1.6 | Yes | DWS Length (in) | 24.0 |
