Access Compliance Report

Public Rights-of-Way

(Curb Ramps)

Intersection ID: 14076	Main Street: W_TYVOLA_RD	Cross Street: WEST_BV	Location: SW
ADA ID: D15C585806F5	Ramp Type: Perp	Initial Pass/Fail: Fail	Overall Compliance: No
Severity Score: 33.75			
Codes/Mitigation Info/Possible Solution		Field Measurements/Component Compliance

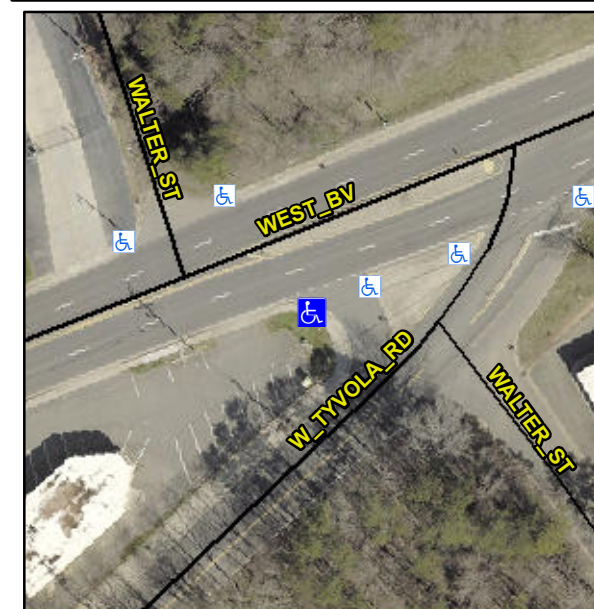
Compliance	Description	Data	Compliance	Description	Data
N/A	Ramp Length (in)	50.0	Yes	Ramp Slope (%)	6.4
No	Ramp Width (in)	36.0	No	Ramp XSlope (%)	8.4
N/A	Flare Type LT	N/A	N/A	Flare Type RT	N/A
N/A	Flare Slope LT (%)	N/A	N/A	Flare Slope RT (%)	N/A
N/A	Flare Traversable LT?	N/A	N/A	Flare Traversable RT?	N/A
N/A	Landing Length (in)	N/A	N/A	DWS Provided?	N/A
N/A	Landing Width (in)	N/A	N/A	DWS Contrast?	N/A
N/A	Landing Slope (%)	N/A	N/A	DWS Length (in)	N/A
N/A	Landing X Slope (%)	N/A	N/A	DWS Full Width?	N/A
N/A	Landing Curb? (Y/N)	N/A	N/A	DWS Offset (in)	N/A
N/A	Shared Landing?	N/A			
N/A	Gutter Ponding?	N/A	N/A	Gutter Slope (%)	N/A
N/A	Gutter Lip Ht (in)	N/A	N/A	Gutter X Slope (%)	N/A
N/A	Painted X Walk1?	No	N/A	Painted X Walk2?	N/A
	X Walk 1 Direction	To E		X Walk 2 Direction	N/A
N/A	X Walk 1 Width (in)	N/A	N/A	X Walk 2 Width (in)	N/A
	X Walk 1 Slope (%)	5.7		X Walk 2 Slope (%)	N/A
	X Walk 1 X Slope (%)	15.0		X Walk 2 X Slope (%)	N/A

N/A	Ramp inside XWalk1?	N/A	N/A	Ramp inside XWalk2?	N/A
	Road Slope (%)	N/A	N/A	Clear Space?	N/A
	Road X Slope (%)	N/A	N/A	Clear Space to XWalk (in)	N/A
N/A	Any Obstructions?	N/A	N/A	Storm Grate/Utility Hazard?	N/A
	Obstruction Type			Storm Grate/Utility Type	
		N/A			N/A
		Yes		Surface Condition? (G/P)	Good

Possible Solutions:

Remove & Replace Entire Ramp.

R304.5.1, R304.5.3
