Access Compliance Report

Public Rights-of-Way

(Curb Ramps)

Intersection ID: 10023378	Main Street: CHINA GROVE CHURCH RD	Cross Street: N/A	Location: NE
ADA ID: D176B4D8DF55	Ramp Type: PerpDiag	Initial Pass/Fail: Fail	Overall Compliance: No
Severity Score: 21.25			
Codes/Mitigation Info/Possible Solution		Field Measurements/Component Compliance

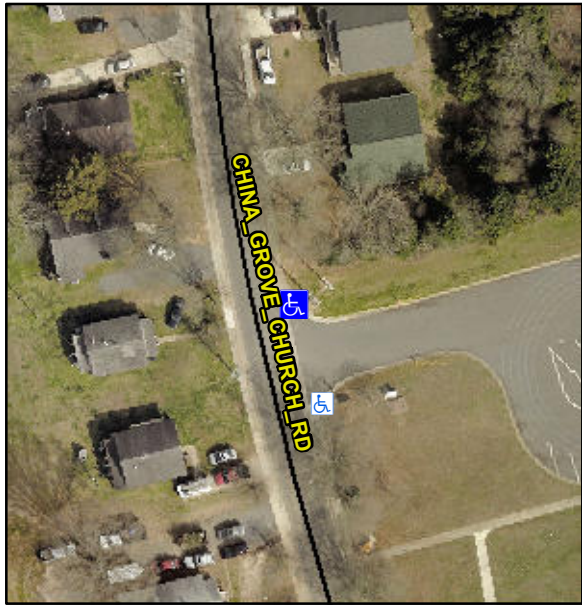
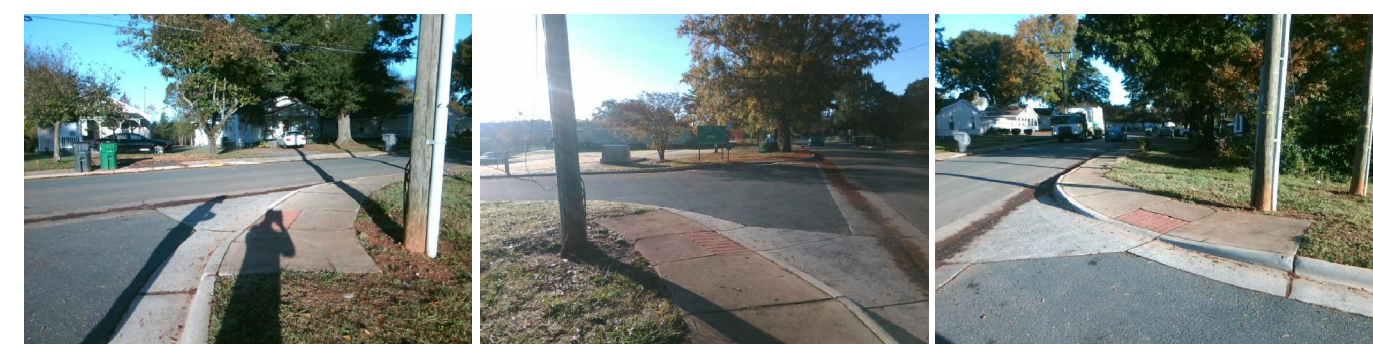
Compliance	Description	Data	Compliance	Description	Data
N/A	Ramp Length (in)	60.0	No	Ramp Slope (%)	9.6
No	Ramp Width (in)	47.0	Yes	Ramp XSlope (%)	1.6
N/A	Flare Type LT	N/A	N/A	Flare Type RT	N/A
N/A	Flare Slope LT (%)	N/A	N/A	Flare Slope RT (%)	N/A
N/A	Flare Traversable LT?	N/A	N/A	Flare Traversable RT?	N/A
N/A	Landing Length (in)	N/A	N/A	DWS Provided?	N/A
N/A	Landing Width (in)	N/A	N/A	DWS Contrast?	N/A
N/A	Landing Slope (%)	N/A	N/A	DWS Length (in)	N/A
N/A	Landing X Slope (%)	N/A	N/A	DWS Full Width?	N/A
N/A	Landing Curb? (Y/N)	N/A	N/A	DWS Offset (in)	N/A
N/A	Shared Landing?	N/A			
N/A	Gutter Ponding?	N/A	N/A	Gutter Slope (%)	N/A
N/A	Gutter Lip Ht (in)	N/A	N/A	Gutter X Slope (%)	N/A
N/A	Painted X Walk1?	No	N/A	Painted X Walk2?	No
	X Walk 1 Direction	To W		X Walk 2 Direction	To S
N/A	X Walk 1 Width (in)	N/A	N/A	X Walk 2 Width (in)	N/A
	X Walk 1 Slope (%)	4.0		X Walk 2 Slope (%)	2.0
	X Walk 1 X Slope (%)	0.7		X Walk 2 X Slope (%)	1.0

N/A	Ramp inside XWalk1?	N/A	N/A	Ramp inside XWalk2?	N/A
	Road Slope (%)	0.5	N/A	Clear Space?	N/A
	Road X Slope (%)	2.1	N/A	Clear Space to XWalk (in)	N/A
N/A	Any Obstructions?	N/A	N/A	Storm Grate/Utility Hazard?	N/A
	Obstruction Type			Storm Grate/Utility Type	
		N/A			N/A
			Yes	Surface Condition? (G/P)	Good

Possible Solutions:		Remove & Replace Curb Ramp With Two New Directional Ramps or Equivalent.	
	Surveyor Notes:		N/A	
	PROW/ADA:		Not Found, R304.5.1, R304.2.2	
	Street 1 Name		CHINA GROVE CHURCH RD	
	Stop Condition-Street 2		None	
	Street 2 Name		ENTRANCE	
	Stop Condition-Street 1		None	
	Total Cost:		\$ 3200.00
