11.6

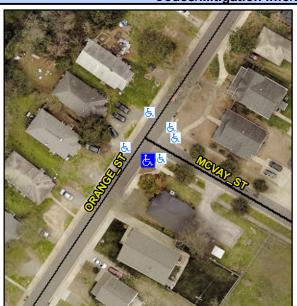
Street 1 Name	ORANGE ST
Stop Condition-Street 1	None
Street 2 Name	N/A
Stop Condition-Street 2	N/A

ossible solution	ried Measurements/Component Comphance					
Possible Solutions:	Compliance Description		Data	Compl	iance Description	
Remove & Replace Entire Ramp.	N/A	Ramp Length (in)	62.5	Yes	Grade Break?	
·	Yes	Ramp Width (in)	62.0	No	Grade Break Slope (%)	
	Yes	Ramp Slope (%)	5.7	Yes	Grade Break XSlope (%)	
	Yes	Ramp XSlope (%)	2.3			
	Yes	Flare Type LT	N/A	Yes	Flare Type RT	
	N/A	Flare Slope LT (%)	N/A	N/A	Flare Slope RT (%)	
Surveyor Notes:	N/A	Flare Traversable LT?	No	N/A	Flare Traversable RT?	
N/A	Yes	Landing Length (in)	69.0	Yes	DWS Provided?	
	Yes	Landing Width (in)	62.0	Yes	DWS Contrast?	
	Yes	Landing Slope (%)	1.3	Yes	DWS Length (in)	
	No	Landing X Slope (%)	2.2	Yes	DWS Full Width?	
PROW/ADA:	N/A	Landing Curb? (Y/N)	N/A	No	DWS Offset LT (in)	
Not Found, R304.5.3, R305.2	N/A	Shared Landing?	Yes	Yes	DWS Offset RT (in)	
	Yes	Gutter Ponding?	No	Yes	Gutter Slope (%)	
	Yes	Gutter Lip Ht (in)	0.0	Yes	Gutter X Slope (%)

N/A	Painted X Walk1?	No		Road Slope (%)	
		X Walk 1 Direction	To W		Road X Slope (%)	
		X Walk 1 Width (in)	N/A		Clear Space?	
		X Walk 1 Slope (%)	2.9	N/A	Clear Space to XWalk (in)	
		X Walk 1 X Slope (%)	4.7	Yes	Storm Grate/Utility Hazard?	
	N/A	Ramp inside XWalk1?	N/A		Storm Grate/Utility Type	
	Yes	Any Obstructions?	No
