Access Compliance Report

Public Rights-of-Way

(Curb Ramps)

Intersection ID: 20208	Main Street: PINEBURR_CT	Cross Street: PINEBURR_RD	Location: NE
ADA ID: D190A8DEAB23	Ramp Type: PerpDiag	Initial Pass/Fail: Fail	Overall Compliance: No
		Severity Score: 10

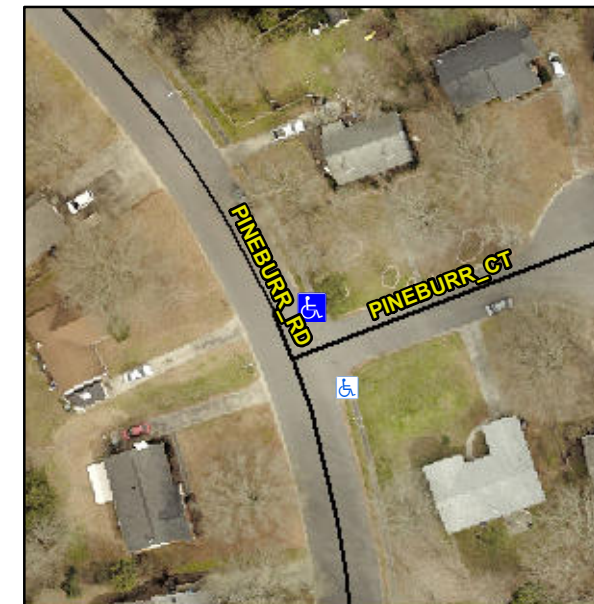
Not Found, R304.5.1, R304.5.3

Compliance	Description	Data	Compliance	Description	Data
N/A	Ramp Length (in)	30.0	Yes	Ramp Slope (%)	7.3
No	Ramp Width (in)	43.0	No	Ramp XSlope (%)	4.2
N/A	Flare Type LT	N/A	N/A	Flare Type RT	N/A
N/A	Flare Slope LT (%)	N/A	N/A	Flare Slope RT (%)	N/A
N/A	Flare Traversable LT?	N/A	N/A	Flare Traversable RT?	N/A
N/A	Landing Length (in)	N/A	N/A	DWS Provided?	N/A
N/A	Landing Width (in)	N/A	N/A	DWS Contrast?	N/A
N/A	Landing Slope (%)	N/A	N/A	DWS Length (in)	N/A
N/A	Landing X Slope (%)	N/A	N/A	DWS Full Width?	N/A
N/A	Landing Curb? (Y/N)	N/A	N/A	DWS Offset (in)	N/A
N/A	Shared Landing?	N/A			
N/A	Gutter Ponding?	N/A	N/A	Gutter Slope (%)	N/A
N/A	Gutter Lip Ht (in)	N/A	N/A	Gutter X Slope (%)	N/A
N/A	Painted X Walk1?	No	N/A	Painted X Walk2?	No
	X Walk 1 Direction	To NW		X Walk 2 Direction	To SE
N/A	X Walk 1 Width (in)	N/A	N/A	X Walk 2 Width (in)	N/A
	X Walk 1 Slope (%)	1.8		X Walk 2 Slope (%)	1.6
	X Walk 1 X Slope (%)	1.0		X Walk 2 X Slope (%)	1.1

Remove & Replace Curb Ramp With Two New Directional Ramps or Equivalent.
