## Access Compliance Report Public Rights-of-Way (Curb Ramps)

•		-					
Intersection ID: 45282	Intersection ID: 45282 Main Street: ARWEN_RD			Street:	VALLEY_RIDGE_RD	Location:	NW		
ADA ID: D19370BD60A1	70BD60A1 Ramp Type: PerpDiag			Initial Pass/Fail: Fail Overall Compliance: No				o Severity Score:	72.5
Codes/Mitigation Info/Possible Solution				Field Measurements/Component Compliance					
		Possible Solutions:		Compliance Description			Data Compliance Description		Data
		Remove & Replace Curb Ramp V	Nith	N/A	Ramp Length (in)	49.0	No	Ramp Slope (%)	10.8
		Two New Directional Ramps or		No	Ramp Width (in)	26.0	No	Ramp XSlope (%)	14.0
		Equivalent.		N/A	Flare Type LT	N/A	N/A	Flare Type RT	N/A
	1 OK. S			N/A	Flare Slope LT (%)	N/A	N/A	Flare Slope RT (%)	N/A
	450			N/A	Flare Traversable LT?	N/A	N/A	Flare Traversable RT?	N/A
Carlos Carlos	h and h			N/A	Landing Length (in)	N/A	N/A	DWS Provided?	N/A
		Surveyor Notes:		N/A	Landing Width (in)	N/A	N/A	DWS Contrast?	N/A

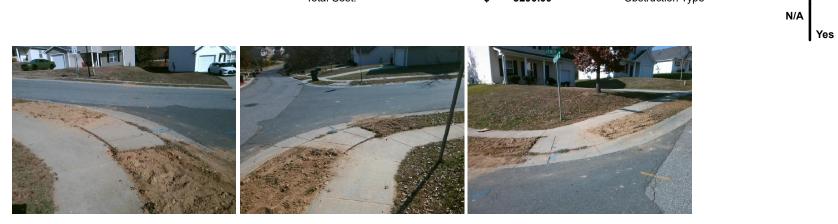
B B B	Non al	N/A		N/A	Landing Slope (%)	N/A	N/A	DWS Length (in)	N/A
PROW/ADA: Not Found, R304.5.1, R304.2.2, R304.5.3				N/A	Landing X Slope (%)	N/A	N/A	DWS Full Width?	N/A
				N/A	Landing Curb? (Y/N)	N/A	N/A	DWS Offset (in)	N/A
				N/A	Shared Landing?	N/A			
				N/A	Gutter Ponding?	N/A	N/A	Gutter Slope (%)	N/A
				N/A	Gutter Lip Ht (in)	N/A	N/A	Gutter X Slope (%)	N/A
				N/A	Painted X Walk1?	No	N/A	Painted X Walk2?	No
					X Walk 1 Direction	To SE		X Walk 2 Direction	To NE
				N/A	X Walk 1 Width (in)	N/A	N/A	X Walk 2 Width (in)	N/A
Street 1 Name	VALLEY RIDGE RD	•			X Walk 1 Slope (%)	3.9		X Walk 2 Slope (%)	3.6
Stop Condition-Street 2	StopSign				X Walk 1 X Slope (%)	5.7		X Walk 2 X Slope (%)	7.9
Street 2 Name	ARWEN RD			N/A	Ramp inside XWalk1?	N/A	N/A	Ramp inside XWalk2?	N/A
Stop Condition-Street 1	None				, Road Slope (%)	11.5	N/A	Clear Space?	N/A

• •					Road X Slope (%)	0.5	N/A	Clear Space to XWalk (in)	N/A
				N/A	Any Obstructions?	N/A	N/A	Storm Grate/Utility Hazard?	N/A
		Total Cost: \$ 3	3200.00		Obstruction Type			Storm Grate/Utility Type	
					51	N/A			N/A
