## **Access Compliance Report Public Rights-of-Way** (Curb Ramps)

Main Street: BALLANTYNE\_CORPORATE\_PCross Street: N/A Intersection ID: 10020377 Location: SE

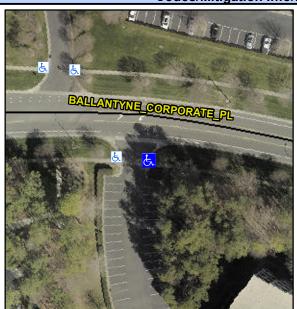
Initial Pass/Fail: Fail

Ramp Type: Perp

**Overall Compliance: No**

**ENTRANCE** Street 1 Name Stop Condition-Street 2 StopSign N/A Street 2 Name Stop Condition-Street 1 N/A Possible Solutions: Compliance Description N/A Remove & Replace Entire Ramp. Yes N/A N/A N/A N/A Surveyor Notes: N/A N/A N/A N/A N/A N/A PROW/ADA: N/A Not Found, R304.2.2 N/A N/A N/A N/A
