Access Compliance Report

Public Rights-of-Way

(Curb Ramps)

Intersection ID: 10038838	Main Street: STEELECROFT_PY	Cross Street: N/A	Location: W
ADA ID: D1A0A7567FC5	Ramp Type: PerpDiag	Initial Pass/Fail: Fail	Overall Compliance: No
Severity Score: 33.75			
Codes/Mitigation Info/Possible Solution		Field Measurements/Component Compliance

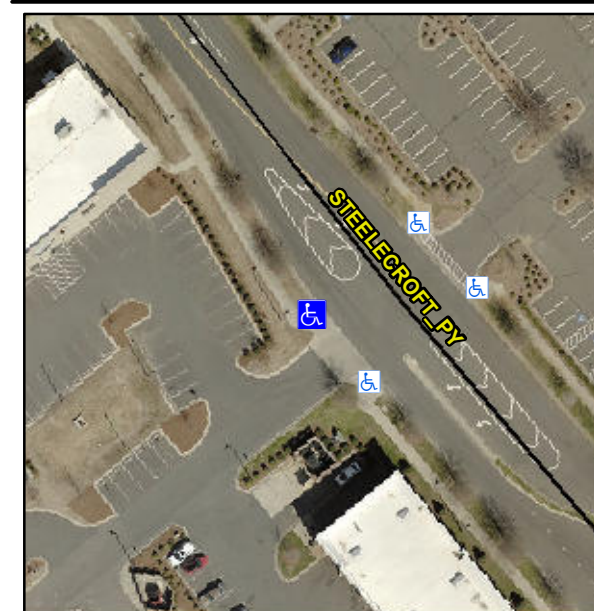
Not Found, R304.5.1, R304.2.2

Compliance	Description	Data	Compliance	Description	Data
N/A	Ramp Length (in)	103.0	No	Ramp Slope (%)	12.8
No	Ramp Width (in)	46.5	Yes	Ramp XSlope (%)	1.5
N/A	Flare Type LT	N/A	N/A	Flare Type RT	N/A
N/A	Flare Slope LT (%)	N/A	N/A	Flare Slope RT (%)	N/A
N/A	Flare Traversable LT?	N/A	N/A	Flare Traversable RT?	N/A
N/A	Landing Length (in)	N/A	N/A	DWS Provided?	N/A
N/A	Landing Width (in)	N/A	N/A	DWS Contrast?	N/A
N/A	Landing Slope (%)	N/A	N/A	DWS Length (in)	N/A
N/A	Landing X Slope (%)	N/A	N/A	DWS Full Width?	N/A
N/A	Landing Curb? (Y/N)	N/A	N/A	DWS Offset (in)	N/A
N/A	Shared Landing?	N/A			
N/A	Gutter Ponding?	N/A	N/A	Gutter Slope (%)	N/A
N/A	Gutter Lip Ht (in)	N/A	N/A	Gutter X Slope (%)	N/A
N/A	Painted X Walk1?	No	N/A	Painted X Walk2?	No
	X Walk 1 Direction	To SE		X Walk 2 Direction	To NE
N/A	X Walk 1 Width (in)	N/A	N/A	X Walk 2 Width (in)	N/A
	X Walk 1 Slope (%)	0.7		X Walk 2 Slope (%)	1.5
	X Walk 1 X Slope (%)	3.7		X Walk 2 X Slope (%)	1.3

N/A	Ramp inside XWalk1?	N/A	N/A	Ramp inside XWalk2?	N/A
	Road Slope (%)	2.9	N/A	Clear Space?	N/A
	Road X Slope (%)	7.6	N/A	Clear Space to XWalk (in)	N/A
N/A	Any Obstructions?	N/A	N/A	Storm Grate/Utility Hazard?	N/A
	Obstruction Type			Storm Grate/Utility Type	
		N/A			N/A
			Yes	Surface Condition? (G/P)	Good

Possible Solutions:

Remove & Replace Curb Ramp With Two New Directional Ramps or Equivalent.
