Access Compliance Report Public Rights-of-Way (Curb Ramps)

Intersection ID: 25959 Main Street: CAMBRIDGE HILL LN **Cross Street: PROVIDENCE_RD** Location: NE **ADA ID: D1A25574FFB6** Ramp Type: Perp Initial Pass/Fail: Fail **Overall Compliance: No** Severity Score: 21.25

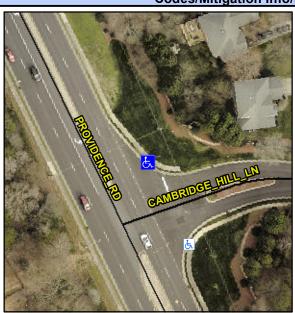
Field Measurements/Component Compliance						
Compliance Description		Data	Comp	liance	Description	Data
N/A	Ramp Length (in)	76.0	Yes	Ramp	Slope (%)	6.3
No	Ramp Width (in)	38.0	No	Ramp	XSlope (%)	6.5
N/A	Flare Type LT	N/A	N/A	Flare Type RT		N/A
N/A	Flare Slope LT (%)	N/A	N/A	Flare	Slope RT (%)	N/A
N/A	Flare Traversable LT?	N/A	N/A	Flare	Traversable RT?	N/A
N/A	Landing Length (in)	N/A	N/A	DWS	Provided?	N/A
N/A	Landing Width (in)	N/A	N/A	DWS	Contrast?	N/A
N/A	Landing Slope (%)	N/A	N/A	DWS	Length (in)	N/A
N/A	Landing X Slope (%)	N/A	N/A	DWS	Full Width?	N/A
N/A	Landing Curb? (Y/N)	N/A	N/A	DWS	Offset (in)	N/A
N/A	Shared Landing?	N/A				
N/A	Gutter Ponding?	N/A	N/A	Gutte	er Slope (%)	N/A
N/A	Gutter Lip Ht (in)	N/A	N/A	Gutte	er X Slope (%)	N/A
N/A	Painted X Walk1?	No	N/A	Paint	ed X Walk2?	N/A
	X Walk 1 Direction	To S		X Wa	lk 2 Direction	N/A
N/A	X Walk 1 Width (in)	N/A	N/A	X Wa	ılk 2 Width (in)	N/A
	X Walk 1 Slope (%)	5.4		X Wa	lk 2 Slope (%)	N/A

X Walk 1 X Slope (%)	1.3		X Wa	lk 2 X Slope (%)	N/A
N/A	Ramp inside XWalk1?	N/A	N/A	Ram	o inside XWalk2?	N/A
	Road Slope (%)	N/A	N/A	Clear	Space?	N/A
	Road X Slope (%)	N/A	N/A	Clear	Space to XWalk (in)	N/A
N/A	Any Obstructions?	N/A	N/A	Storn	n Grate/Utility Hazard?	N/A
	Obstruction Type			Storn	n Grate/Utility Type	
		N/A				N/A
			Yes	Surfa	ce Condition? (G/P)	Good

Possible Solutions: Remove & Replace Entire Ramp. Surveyor Notes: N/A PROW/ADA: Not Found, R304.5.1, R304.5.3

Total Cost: 1850.00
