# Access Compliance Report

## Public Rights-of-Way

### (Curb Ramps)

Intersection ID: N/A	Main Street: CAROLINA_PAVILION_DR	Cross Street: N/A	Location: NW
ADA ID: D1AF3BF1B571	Ramp Type: Perp	Initial Pass/Fail: Fail	Overall Compliance: No
		Severity Score: 12.5

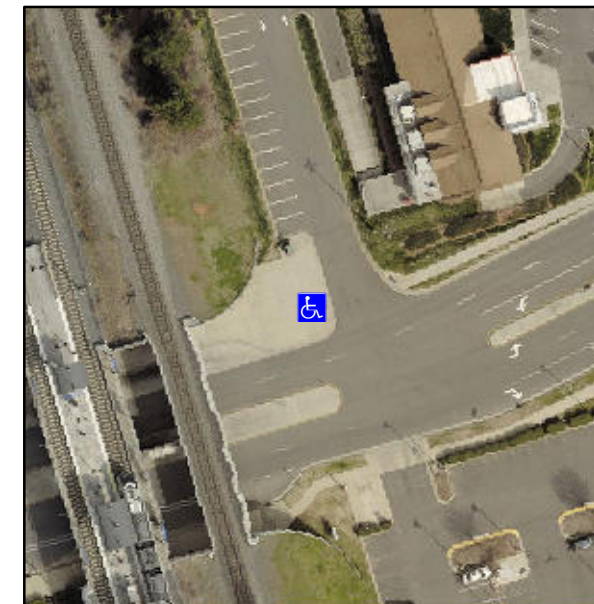
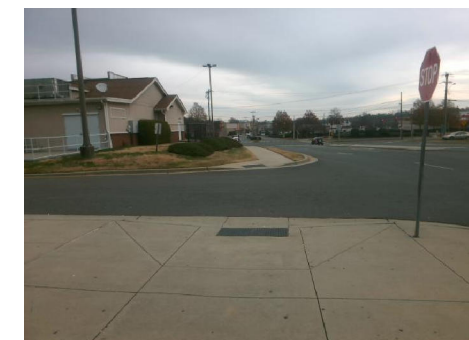
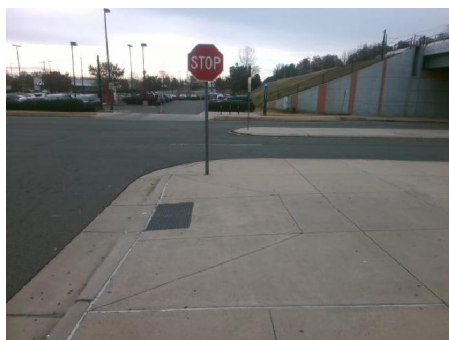
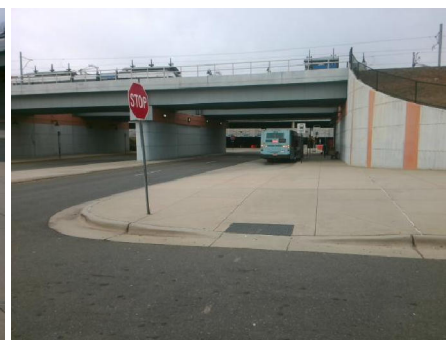
**Not Found, R304.5.3**

Compliance	Description	Data	Compliance	Description	Data
N/A	Ramp Length (in)	83.0	Yes	Ramp Slope (%)	8.2
Yes	Ramp Width (in)	48.0	No	Ramp XSlope (%)	6.0
N/A	Flare Type LT	N/A	N/A	Flare Type RT	N/A
N/A	Flare Slope LT (%)	N/A	N/A	Flare Slope RT (%)	N/A
N/A	Flare Traversable LT?	N/A	N/A	Flare Traversable RT?	N/A
N/A	Landing Length (in)	N/A	N/A	DWS Provided?	N/A
N/A	Landing Width (in)	N/A	N/A	DWS Contrast?	N/A
N/A	Landing Slope (%)	N/A	N/A	DWS Length (in)	N/A
N/A	Landing X Slope (%)	N/A	N/A	DWS Full Width?	N/A
N/A	Landing Curb? (Y/N)	N/A	N/A	DWS Offset (in)	N/A
N/A	Shared Landing?	N/A			
N/A	Gutter Ponding?	N/A	N/A	Gutter Slope (%)	N/A
N/A	Gutter Lip Ht (in)	N/A	N/A	Gutter X Slope (%)	N/A
N/A	Painted X Walk1?	No	N/A	Painted X Walk2?	N/A
	X Walk 1 Direction	To E		X Walk 2 Direction	N/A
N/A	X Walk 1 Width (in)	N/A	N/A	X Walk 2 Width (in)	N/A
	X Walk 1 Slope (%)	0.3		X Walk 2 Slope (%)	N/A
	X Walk 1 X Slope (%)	1.9		X Walk 2 X Slope (%)	N/A

N/A	Ramp inside XWalk1?	N/A	N/A	Ramp inside XWalk2?	N/A
	Road Slope (%)	N/A	N/A	Clear Space?	N/A
	Road X Slope (%)	N/A	N/A	Clear Space to XWalk (in)	N/A
N/A	Any Obstructions?	N/A	N/A	Storm Grate/Utility Hazard?	N/A
	Obstruction Type			Storm Grate/Utility Type	
		N/A			N/A
			Yes	Surface Condition? (G/P)	Good

**Remove & Replace Entire Ramp.**

\$ 1850.00
