Intersection ID: 8676	Main Street: HERSHEY_ST	Cross Street: WELLINGFORD_ST	Location:	NE
ADA ID: D1B0B7C343B6	Ramp Type: Perp	Initial Pass/Fail: Fail	Overall Compliance: No	Severity Score: 25

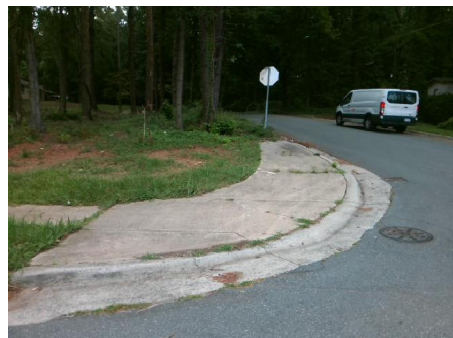
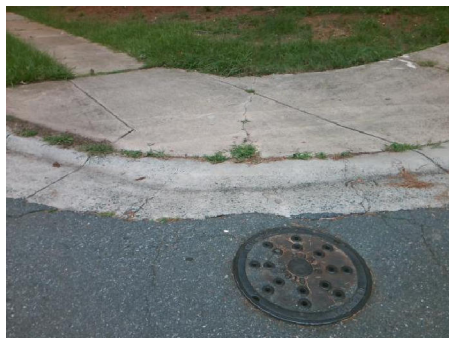
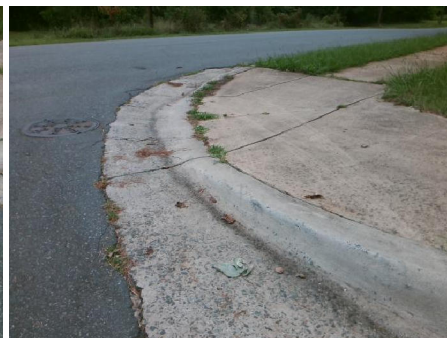
Not Found, R304.5.3

Compliance	Description	Data	Compliance	Description	Data
N/A	Ramp Length (in)	18.0	Yes	Ramp Slope (%)	5.8
Yes	Ramp Width (in)	48.0	No	Ramp XSlope (%)	8.9
N/A	Flare Type LT	N/A	N/A	Flare Type RT	N/A
N/A	Flare Slope LT (%)	N/A	N/A	Flare Slope RT (%)	N/A
N/A	Flare Traversable LT?	N/A	N/A	Flare Traversable RT?	N/A
N/A	Landing Length (in)	N/A	N/A	DWS Provided?	N/A
N/A	Landing Width (in)	N/A	N/A	DWS Contrast?	N/A
N/A	Landing Slope (%)	N/A	N/A	DWS Length (in)	N/A
N/A	Landing X Slope (%)	N/A	N/A	DWS Full Width?	N/A
N/A	Landing Curb? (Y/N)	N/A	N/A	DWS Offset (in)	N/A
N/A	Shared Landing?	N/A			
N/A	Gutter Ponding?	N/A	N/A	Gutter Slope (%)	N/A
N/A	Gutter Lip Ht (in)	N/A	N/A	Gutter X Slope (%)	N/A
N/A	Painted X Walk1?	No	N/A	Painted X Walk2?	N/A
	X Walk 1 Direction	To S		X Walk 2 Direction	N/A
N/A	X Walk 1 Width (in)	N/A	N/A	X Walk 2 Width (in)	N/A
	X Walk 1 Slope (%)	2.8		X Walk 2 Slope (%)	N/A
	X Walk 1 X Slope (%)	6.7		X Walk 2 X Slope (%)	N/A

N/A	Ramp inside XWalk1?	N/A	N/A	Ramp inside XWalk2?	N/A
	Road Slope (%)	N/A	N/A	Clear Space?	N/A
	Road X Slope (%)	N/A	N/A	Clear Space to XWalk (in)	N/A
N/A	Any Obstructions?	N/A	N/A	Storm Grate/Utility Hazard?	N/A
	Obstruction Type			Storm Grate/Utility Type	
		N/A			N/A
			Yes	Surface Condition? (G/P)	Good

Remove & Replace Entire Ramp.

Total Cost: \$ 1850.00
