Access Compliance Report Public Rights-of-Way (Curb Ramps)

Intersection ID: 17865 Main Street: OVERHILL_RD Cross Street: S_WENDOVER_RD Location: W

ADA ID: D1CA44B1DD63 Ramp Type: BlendTrans1 Initial Pass/Fail: Fail Overall Compliance: No Severity Score: 25

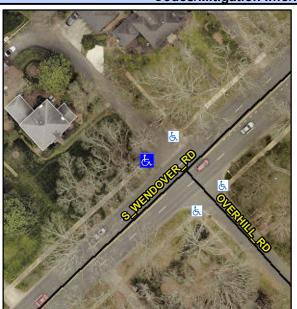
Not Found, R304.5.3

| Compliance Description Data | | Compliance Description | | Data | |
|---|---|---|---|---|---|
| Yes | Ramp Width (in) | 48.0 | No | BlendTrans XSlope (%) | 7.5 |
| At a second | | | No | Curb Slope (%) | 22.5 |

Remove & Replace Curb Ramp With Two New Directional Ramps or Equivalent.

Total Cost: \$ 3200.00
