# Access Compliance Report

## Public Rights-of-Way

### (Curb Ramps)

| Intersection ID: 12770 | Main Street: HICKORY GROVE RD | Cross Street: N_SHARON AMITY RD | Location: NE |

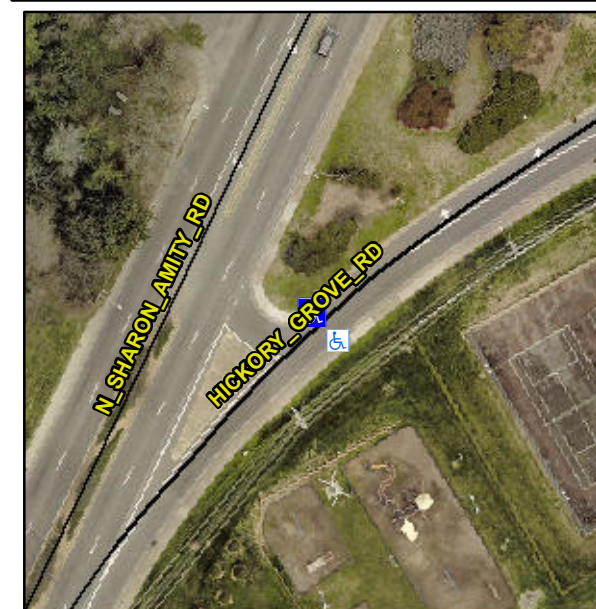
**Not Found, R304.5.1, R304.2.2**

| Compliance | Description | Data | Compliance | Description | Data |
|---|---|---|---|---|---|
| N/A | Ramp Length (in) | 61.0 | No | Ramp Slope (%) | 9.3 |
| No | Ramp Width (in) | 47.0 | Yes | Ramp XSlope (%) | 3.0 |

**Remove & Replace Entire Ramp.**
