Access Compliance Report Public Rights-of-Way (Curb Ramps)

Intersection ID: 51630Main Street:STEELECROFT_PYCross Street:CLOISTERS_CLUB_LNLocation:NEADA ID: D1CF5585587ARamp Type:Directional1Initial Pass/Fail:FailOverall Compliance:NoSeverity Score:1.25

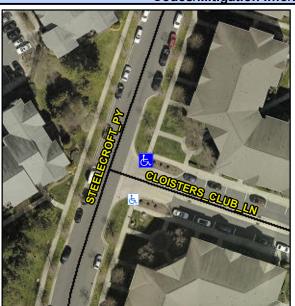
Paraller and Baselutter Bate Organization Baselutter Bate						
	liance Description	Data	Compliance Description			Data
N/A	Ramp Length (in)	39.0	N/A	Grade Break?		N/A
Yes	Ramp Width (in)	60.0	N/A	Grade Break Slope (%)		0.0
es/	Ramp Slope (%)	0.9	N/A	Grade Break XSlope (%)		0.0
No	Ramp XSlope (%)	3.2				
N/A	Flare Type LT	N/A	N/A	Flare Type RT		N/A
N/A	Flare Slope LT (%)	N/A	N/A	Flare	Slope RT (%)	0.0
N/A	Flare Traversable LT?	N/A	N/A	Flare	Traversable RT?	N/A
N/A	Landing Length (in)	0.0	N/A	DWS	Provided?	N/A
N/A	Landing Width (in)	0.0	N/A	DWS	Contrast?	N/A
N/A	Landing Slope (%)	0.0	N/A	DWS	Length (in)	N/A
N/A	Landing X Slope (%)	0.0	N/A	DWS	Full Width?	N/A
N/A	Landing Curb? (Y/N)	N/A	N/A	DWS	Offset LT (in)	N/A
N/A	Shared Landing?	N/A	N/A	DWS	Offset RT (in)	N/A
N/A	Gutter Ponding?	0.0	N/A	Gutte	er Slope (%)	N/A
N/A	Gutter Lip Ht (in)	0.0	N/A	Gutte	er X Slope (%)	N/A
N/A	Painted X Walk1?	No		Road	Slope (%)	1.2

X Walk 1 Direction	To S		Road	X Slope (%)	1.4
	X Walk 1 Width (in)	N/A		Clea	Space?	N/A
	X Walk 1 Slope (%)	1.2	N/A	Clea	Space to XWalk (in)	N/A
	X Walk 1 X Slope (%)	1.4	N/A	Storr	n Grate/Utility Hazard?	N/A
N/A	Ramp inside XWalk1?	N/A		Storr	n Grate/Utility Type	
N/A	Any Obstructions?	N/A				N/A
	Obstruction Type		Yes	Surfa	ce Condition? (G/P)	Good
		N/A	N/A	Curb	Slope (%)	5.5
		,	-

Remove & Replace Entire Ramp.

R304.5.3
