# Access Compliance Report

## Public Rights-of-Way

### (Curb Ramps)

Intersection ID: 10154	Main Street: SLOAN_DR	Cross Street: TUCKASEEGEE_RD	Location: S
ADA ID: D1D783F0E86A	Ramp Type: Perp	Initial Pass/Fail: Fail	Overall Compliance: No
			Severity Score: 43.75

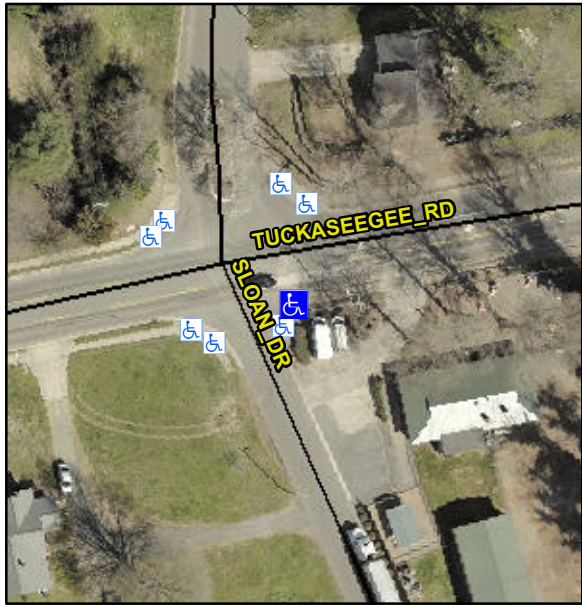
Possible Solutions:		Compliance	Description	Data	Compliance	Description	Data
	Remove & Replace Entire Ramp.		N/A	Ramp Length (in)	60.0	No	Ramp Slope (%)	13.7
			No	Ramp Width (in)	32.0	No	Ramp XSlope (%)	2.8
			N/A	Flare Type LT	N/A	N/A	Flare Type RT	N/A
			N/A	Flare Slope LT (%)	N/A	N/A	Flare Slope RT (%)	N/A
			N/A	Flare Traversable LT?	N/A	N/A	Flare Traversable RT?	N/A
			N/A	Landing Length (in)	N/A	N/A	DWS Provided?	N/A
			N/A	Landing Width (in)	N/A	N/A	DWS Contrast?	N/A
			N/A	Landing Slope (%)	N/A	N/A	DWS Length (in)	N/A
			N/A	Landing X Slope (%)	N/A	N/A	DWS Full Width?	N/A
Surveyor Notes:			N/A	Landing Curb? (Y/N)	N/A	N/A	DWS Offset (in)	N/A
PROW/ADA:			N/A	Shared Landing?	N/A			
Not Found, R304.5.1, R304.2.2, R304.5.3			N/A	Gutter Ponding?	Yes	N/A	Gutter Slope (%)	N/A
			N/A	Gutter Lip Ht (in)	N/A	N/A	Gutter X Slope (%)	N/A

N/A	Painted X Walk1?	No	N/A	Painted X Walk2?	N/A
				X Walk 1 Direction	To N		X Walk 2 Direction	N/A
			N/A	X Walk 1 Width (in)	N/A	N/A	X Walk 2 Width (in)	N/A
				X Walk 1 Slope (%)	0.4		X Walk 2 Slope (%)	N/A
				X Walk 1 X Slope (%)	0.4		X Walk 2 X Slope (%)	N/A
			N/A	Ramp inside XWalk1?	N/A	N/A	Ramp inside XWalk2?	N/A
				Road Slope (%)	N/A	N/A	Clear Space?	N/A
				Road X Slope (%)	N/A	N/A	Clear Space to XWalk (in)	N/A
			N/A	Any Obstructions?	N/A	N/A	Storm Grate/Utility Hazard?	N/A
				Obstruction Type			Storm Grate/Utility Type	
						N/A		N/A
						Yes	Surface Condition? (G/P)	Good
