# Access Compliance Report

## Public Rights-of-Way

### (Curb Ramps)

Intersection ID: 26407	Main Street: LAURENHURST_LN	Cross Street: MCKENZIE_CREEK_DR	Location: SW
ADA ID: D1DF824AE962	Ramp Type: BlendTrans1	Initial Pass/Fail: Fail	Overall Compliance: No
Severity Score: 0			
Codes/Mitigation Info/Possible Solution		Field Measurements/Component Compliance

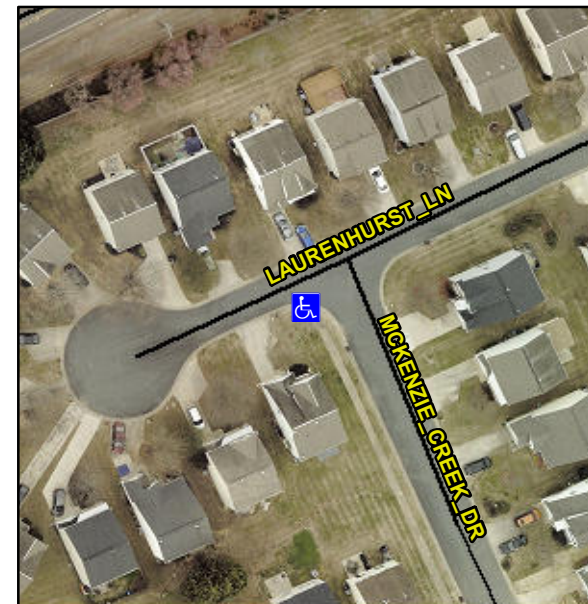
**CURB LIP 1.0**

Compliance	Description	Data	Compliance	Description	Data
N/A	Ramp Length (in)	52.0	Yes	BlendTrans Slope (%)	3.7
Yes	Ramp Width (in)	51.5	Yes	BlendTrans XSlope (%)	1.9
N/A	Flare Type LT	N/A	N/A	Flare Type RT	N/A
N/A	Flare Slope LT (%)	N/A	N/A	Flare Slope RT (%)	N/A
N/A	Flare Traversable LT?	N/A	N/A	Flare Traversable RT?	N/A
N/A	Landing Length (in)	N/A	N/A	DWS Provided?	N/A
N/A	Landing Width (in)	N/A	N/A	DWS Contrast?	N/A
N/A	Landing Slope (%)	N/A	N/A	DWS Length (in)	N/A
N/A	Landing X Slope (%)	N/A	N/A	DWS Full Width?	N/A
N/A	Landing Curb? (Y/N)	N/A	N/A	DWS Offset (in)	N/A
N/A	Shared Landing?	N/A			
N/A	Gutter Ponding?	N/A	N/A	Gutter Slope (%)	N/A
N/A	Gutter Lip Ht (in)	N/A	N/A	Gutter X Slope (%)	N/A
N/A	Painted X Walk1?	No	N/A	Painted X Walk2?	No
	X Walk 1 Direction	To E		X Walk 2 Direction	To N
	X Walk 1 Width (in)	N/A		X Walk 2 Width (in)	N/A
	X Walk 1 Slope (%)	N/A		X Walk 2 Slope (%)	N/A
	X Walk 1 X Slope (%)	N/A		X Walk 2 X Slope (%)	N/A

N/A	Ramp inside XWalk1?	N/A	N/A	Ramp inside XWalk2?	N/A
	Road Slope (%)	1.0		Clear Space?	N/A
	Road X Slope (%)	1.0	N/A	Clear Space to XWalk (in)	N/A
N/A	Any Obstructions?	N/A	N/A	Storm Grate/Utility Hazard?	N/A
	Obstruction Type			Storm Grate/Utility Type	
		N/A			N/A
			Yes	Surface Condition? (G/P)	Good
			No	Curb Slope (%)	8.7

**Remove & Replace Curb Ramp With Two New Directional Ramps or Equivalent.**

Total Cost: \$ **3200.00**
