Access Compliance Report

Public Rights-of-Way

(Curb Ramps)

Intersection ID: 11357	Main Street: W_TRADE_ST	Cross Street: N_IRWIN_AV	Location:	E
ADA ID: D1E24AFEB32F	Ramp Type: Directional1	Initial Pass/Fail: Fail	Overall Compliance: No	Severity Score: 12.5

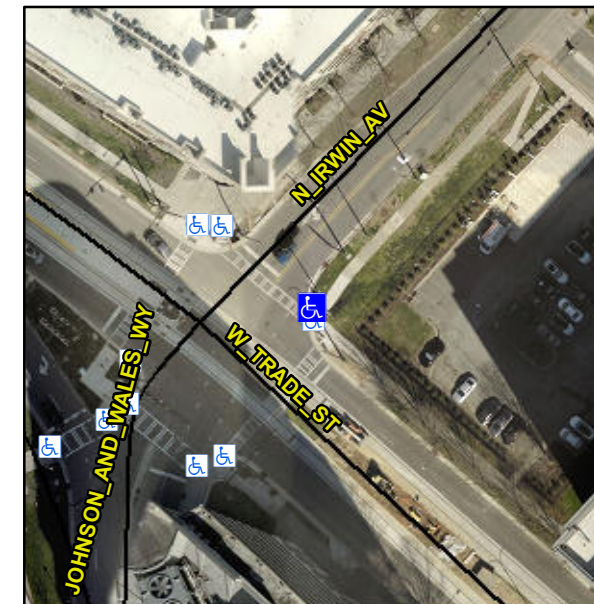
Compliance	Description	Data	Compliance	Description	Data
N/A	Ramp Length (in)	88.0	N/A	Grade Break?	N/A
Yes	Ramp Width (in)	66.5	N/A	Grade Break Slope (%)	0.0
No	Ramp Slope (%)	8.8	N/A	Grade Break XSlope (%)	0.0
Yes	Ramp XSlope (%)	0.3			
N/A	Flare Type LT	N/A	N/A	Flare Type RT	N/A
N/A	Flare Slope LT (%)	N/A	N/A	Flare Slope RT (%)	0.0
N/A	Flare Traversable LT?	N/A	N/A	Flare Traversable RT?	N/A
N/A	Landing Length (in)	0.0	N/A	DWS Provided?	N/A
N/A	Landing Width (in)	0.0	N/A	DWS Contrast?	N/A
N/A	Landing Slope (%)	0.0	N/A	DWS Length (in)	N/A
N/A	Landing X Slope (%)	0.0	N/A	DWS Full Width?	N/A
N/A	Landing Curb? (Y/N)	N/A	N/A	DWS Offset LT (in)	N/A
N/A	Shared Landing?	N/A	N/A	DWS Offset RT (in)	N/A
N/A	Gutter Ponding?	0.0	N/A	Gutter Slope (%)	N/A
N/A	Gutter Lip Ht (in)	0.0	N/A	Gutter X Slope (%)	N/A
N/A	Painted X Walk1?	Yes		Road Slope (%)	2.6
	X Walk 1 Direction	To NW		Road X Slope (%)	0.3
	X Walk 1 Width (in)	54.0		Clear Space?	N/A

X Walk 1 Slope (%)	2.6	N/A	Clear Space to XWalk (in)	N/A
	X Walk 1 X Slope (%)	0.3	N/A	Storm Grate/Utility Hazard?	N/A
N/A	Ramp inside XWalk1?	Yes		Storm Grate/Utility Type	
N/A	Any Obstructions?	N/A			N/A
	Obstruction Type		Yes	Surface Condition? (G/P)	Good
			N/A	Curb Slope (%)	10.2

Possible Solutions:

Remove & Replace Entire Ramp.

R304.2.2
