Access Compliance Report

Public Rights-of-Way

(Curb Ramps)

Intersection ID: 11446	Main Street: GRACE_ST	Cross Street: PEGRAM_ST	Location: NE
ADA ID: D1E61EE1B439	Ramp Type: PerpDiag	Initial Pass/Fail: Fail	Overall Compliance: No
		Severity Score: 8.75

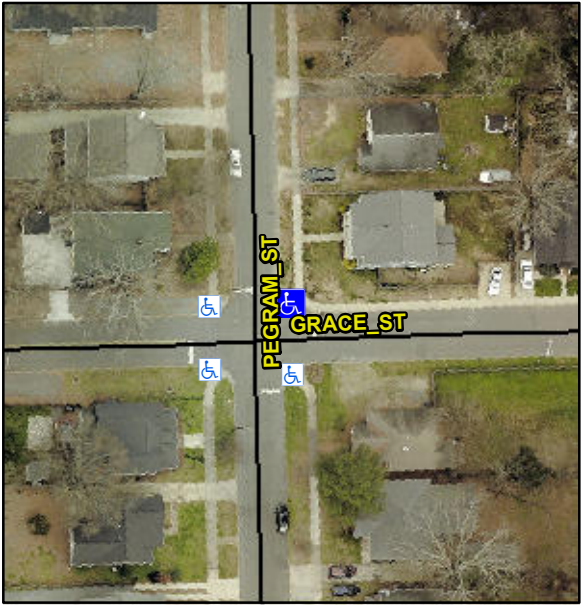
Possible Solutions:		Compliance	Description	Data
	Remove & Replace Curb Ramp With Two New Directional Ramps or Equivalent.		Yes	Ramp Length (in)	6.8
			No	Ramp Width (in)	1.4
			N/A	Flare Type LT	N/A
			N/A	Flare Slope LT (%)	N/A
			N/A	Flare Traversable LT?	N/A
			N/A	Landing Length (in)	N/A
			N/A	Landing Width (in)	N/A
			N/A	Landing Slope (%)	N/A
			N/A	Landing X Slope (%)	N/A
<p>Surveyor Notes:</p> <p>N/A</p> <p>PROW/ADA:</p> <p>Not Found, R304.5.1</p>			N/A	Flare Type RT	N/A
			N/A	Flare Slope RT (%)	N/A
			N/A	Flare Traversable RT?	N/A
			N/A	DWS Provided?	N/A
			N/A	DWS Contrast?	N/A
			N/A	DWS Length (in)	N/A
			N/A	DWS Full Width?	N/A
			N/A	DWS Offset (in)	N/A
			N/A	Gutter Ponding?	N/A
			N/A	Gutter Lip Ht (in)	N/A
<p>Total Cost:</p> <p>\$ 3200.00</p>			No	Painted X Walk1?	No
				X Walk 1 Direction	To W
			N/A	X Walk 1 Width (in)	N/A

4.5	X Walk 1 Slope (%)	4.4
			0.7	X Walk 1 X Slope (%)	3.7
			N/A	Ramp inside XWalk1?	N/A
			1.8	Road Slope (%)	N/A
			3.8	Road X Slope (%)	N/A
			N/A	Any Obstructions?	N/A
				Obstruction Type	
			N/A	Storm Grate/Utility Hazard?	N/A
			N/A	Storm Grate/Utility Type	N/A
			Yes	Surface Condition? (G/P)	Good
