Access Compliance Report

Public Rights-of-Way

(Curb Ramps)

Intersection ID: 20138	Main Street: ARBOR_WY	Cross Street: STEDWICK_PL	Location:	N
ADA ID: D1ED34089F68	Ramp Type: BlendTrans1	Initial Pass/Fail: Fail	Overall Compliance: No	Severity Score: 10
Codes/Mitigation Info/Possible Solution		Field Measurements/Component Compliance

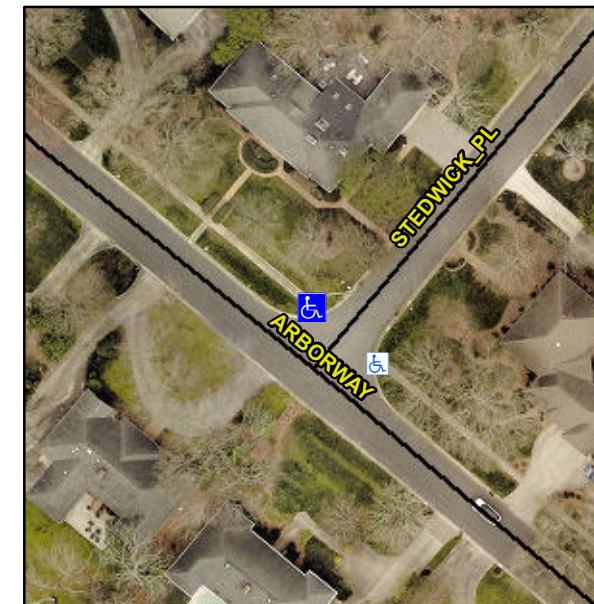
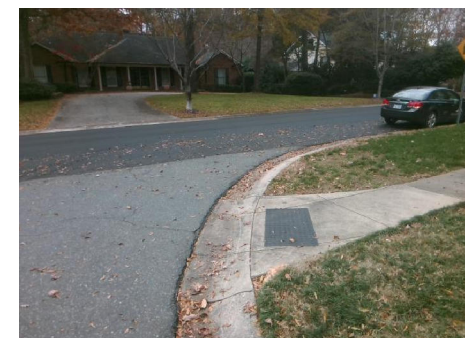
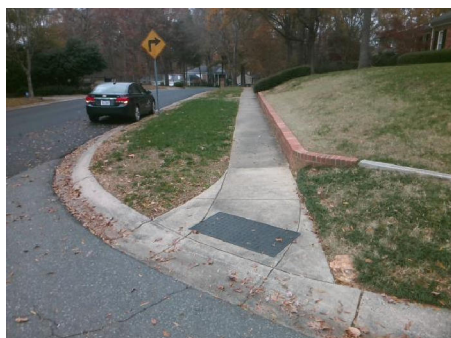
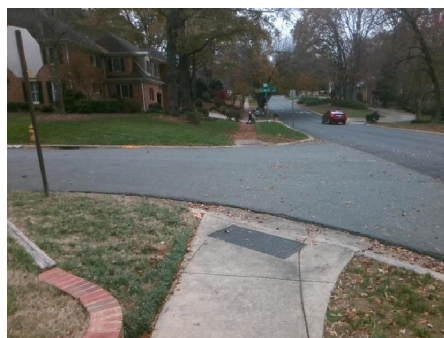
Not Found, R304.5.1, R304.5.3

Compliance	Description	Data	Compliance	Description	Data
N/A	Ramp Length (in)	53.0	Yes	BlendTrans Slope (%)	4.8
No	Ramp Width (in)	47.0	No	BlendTrans XSlope (%)	2.3
N/A	Flare Type LT	N/A	N/A	Flare Type RT	N/A
N/A	Flare Slope LT (%)	N/A	N/A	Flare Slope RT (%)	N/A
N/A	Flare Traversable LT?	N/A	N/A	Flare Traversable RT?	N/A
N/A	Landing Length (in)	N/A	N/A	DWS Provided?	N/A
N/A	Landing Width (in)	N/A	N/A	DWS Contrast?	N/A
N/A	Landing Slope (%)	N/A	N/A	DWS Length (in)	N/A
N/A	Landing X Slope (%)	N/A	N/A	DWS Full Width?	N/A
N/A	Landing Curb? (Y/N)	N/A	N/A	DWS Offset (in)	N/A
N/A	Shared Landing?	N/A			
N/A	Gutter Ponding?	N/A	N/A	Gutter Slope (%)	N/A
N/A	Gutter Lip Ht (in)	N/A	N/A	Gutter X Slope (%)	N/A
N/A	Painted X Walk1?	No	N/A	Painted X Walk2?	No
	X Walk 1 Direction	To SW		X Walk 2 Direction	To SE
	X Walk 1 Width (in)	N/A		X Walk 2 Width (in)	N/A
	X Walk 1 Slope (%)	0.6		X Walk 2 Slope (%)	4.1
	X Walk 1 X Slope (%)	0.7		X Walk 2 X Slope (%)	1.9

N/A	Ramp inside XWalk1?	N/A	N/A	Ramp inside XWalk2?	N/A
	Road Slope (%)	3.2		Clear Space?	N/A
	Road X Slope (%)	2.7	N/A	Clear Space to XWalk (in)	N/A
N/A	Any Obstructions?	N/A	N/A	Storm Grate/Utility Hazard?	N/A
	Obstruction Type			Storm Grate/Utility Type	
		N/A			N/A
			Yes	Surface Condition? (G/P)	Good
			No	Curb Slope (%)	19.5

Remove & Replace Curb Ramp With Two New Directional Ramps or Equivalent.
