# Access Compliance Report

## Public Rights-of-Way

### (Curb Ramps)

| Intersection ID: 48454 | Main Street: RED_RUST_LN | Cross Street: GOLF_LINKS_DR | Location: SE |

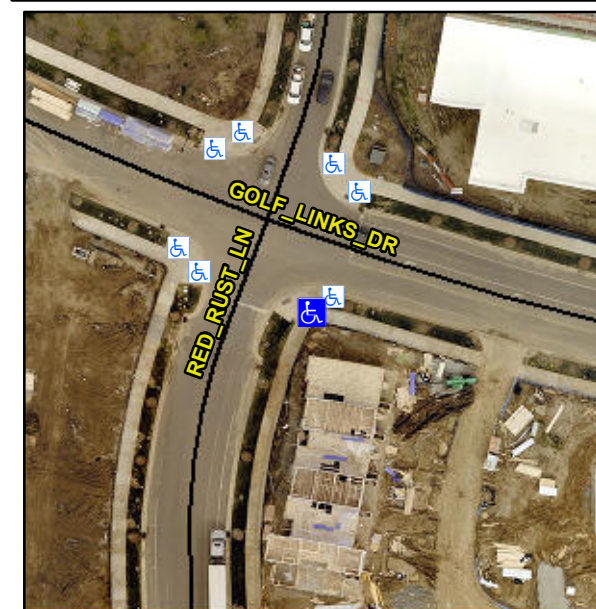
| ADA ID: D1F40AF1A88C | Ramp Type: BlendTrans1 | Initial Pass/Fail: Fail | Overall Compliance: No |
| Severity Score: 1.25 | | | |

**Not Found, R304.5.3**

| Compliance | Description | Data | Compliance | Description | Data |
|---|---|---|---|---|---|
| Yes | Ramp Width (in) | 60.0 | No | BlendTrans XSlope (%) | 4.2 |
| | | | No | Curb Slope (%) | 10.6 |

**Remove & Replace Curb Ramp With Two New Directional Ramps or Equivalent.**

Total Cost: \$ 3200.00
