# Access Compliance Report

## Public Rights-of-Way

### (Curb Ramps)

| Intersection ID: 54364 | Main Street: GANNON_DR | Cross Street: BEREWICK_TOWN_CENTER_DR | Location: N |

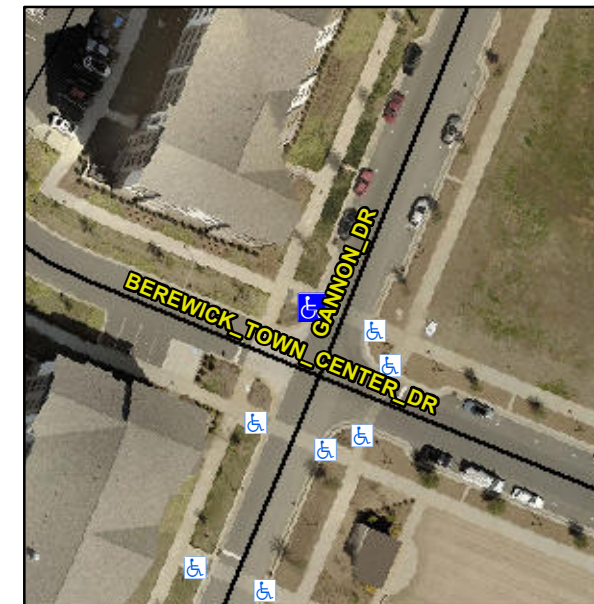
| ADA ID: D1FFCA7548BD | Ramp Type: Perp | Initial Pass/Fail: Pass | Overall Compliance: No |

| Compliance | Description | Data | Compliance | Description | Data |
|---|---|---|---|---|---|
| N/A | Ramp Length (in) | 75.0 | Yes | Ramp Slope (%) | 5.8 |
| Yes | Ramp Width (in) | 93.0 | Yes | Ramp XSlope (%) | 0.5 |
| Yes | Landing Length (in) | 65.0 | Yes | DWS Provided? | Yes |
| Yes | Landing Slope (%) | 2.0 | Yes | DWS Length (in) | 24.0 |

Possible Solutions:

**Remove & Replace Entire Ramp.**

Total Cost: \$ 1850.00

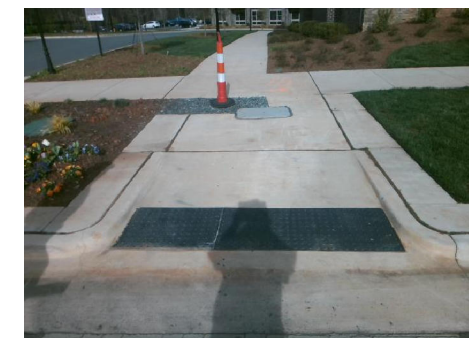
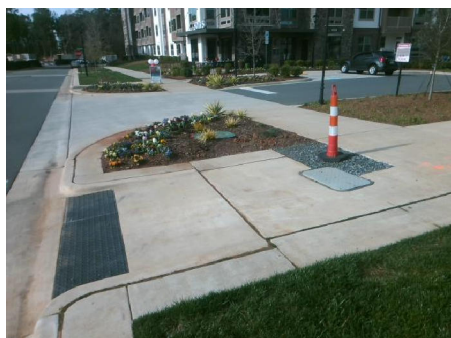
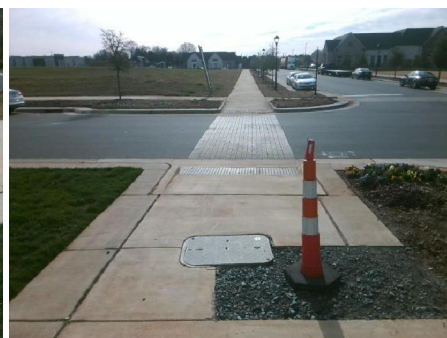
| Compliance | Description | Data | Compliance | Description | Data |
|---|---|---|---|---|---|
| Yes | Any Obstructions? | No | Yes | Storm Grate/Utility Hazard? | No |
| | | | Yes | Surface Condition? (G/P) | Good |
