Access Compliance Report Public Rights-of-Way (Curb Ramps)

Intersection ID: 10037649 Main Street: SEVENTY_SEVEN_CENTER_DRCross Street: N/A Location:

Overall Compliance: No Severity Score: 26.25 **ADA ID: D2052DC46A3C** Ramp Type: Perp Initial Pass/Fail: Fail

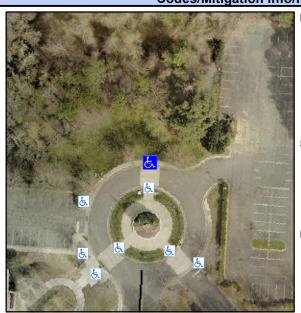
Field Measurements/Component Compliance								
Compl	iance Description	Data	Comp	liance Description	Data			
N/A	Ramp Length (in)	48.5	No	Ramp Slope (%)	14.8			
Yes	Ramp Width (in)	48.0	No	Ramp XSlope (%)	3.8			
N/A	Flare Type LT	N/A	N/A	Flare Type RT	N/A			
N/A	Flare Slope LT (%)	N/A	N/A	Flare Slope RT (%)	N/A			
N/A	Flare Traversable LT?	N/A	N/A	Flare Traversable RT?	N/A			
N/A	Landing Length (in)	N/A	N/A	DWS Provided?	N/A			
N/A	Landing Width (in)	N/A	N/A	DWS Contrast?	N/A			
N/A	Landing Slope (%)	N/A	N/A	DWS Length (in)	N/A			
N/A	Landing X Slope (%)	N/A	N/A	DWS Full Width?	N/A			
N/A	Landing Curb? (Y/N)	N/A	N/A	DWS Offset (in)	N/A			
N/A	Shared Landing?	N/A						
N/A	Gutter Ponding?	N/A	N/A	Gutter Slope (%)	N/A			
N/A	Gutter Lip Ht (in)	N/A	N/A	Gutter X Slope (%)	N/A			
N/A	Painted X Walk1?	No	N/A	Painted X Walk2?	N/A			
	X Walk 1 Direction	To S		X Walk 2 Direction	N/A			
N/A	X Walk 1 Width (in)	N/A	N/A	X Walk 2 Width (in)	N/A

X Walk 1 Slope (%)	2.8		X Walk 2 Slope (%)	N/A			
	X Walk 1 X Slope (%)	1.0		X Walk 2 X Slope (%)	N/A			
N/A	Ramp inside XWalk1?	N/A	N/A	Ramp inside XWalk2?	N/A			
	Road Slope (%)	N/A	N/A	Clear Space?	N/A			
	Road X Slope (%)	N/A	N/A	Clear Space to XWalk (in)	N/A			
N/A	Any Obstructions?	N/A	N/A	Storm Grate/Utility Hazard?	N/A			
	Obstruction Type			Storm Grate/Utility Type				
		N/A			N/A			
1 1 1 1 1 1 1 1 1 1 1 1 1 1 1 1 1 1 1			Yes	Surface Condition? (G/P)	Good

COSIDIC COIGNON	
Possible Solutions:	Comp
Remove & Replace Entire Ramp.	N/A
	Yes
	N/A
	N/A
	N/A
	N/A
Surveyor Notes:	N/A
N/A	N/A
	N/A
	N/A
	N/A
PROW/ADA:	N/A
R304.2.2, R304.5.3	N/A
	N/A
	N/A
	N/A
