# Access Compliance Report

## Public Rights-of-Way

### (Curb Ramps)

Intersection ID: 54324	Main Street: BELMONT_MANSION_DR	Cross Street: ROCKY_HILL_CASTLE_DR	Location:	N
ADA ID: D20A38E07E3D	Ramp Type: Perp	Initial Pass/Fail: Fail	Overall Compliance: No	Severity Score: 25

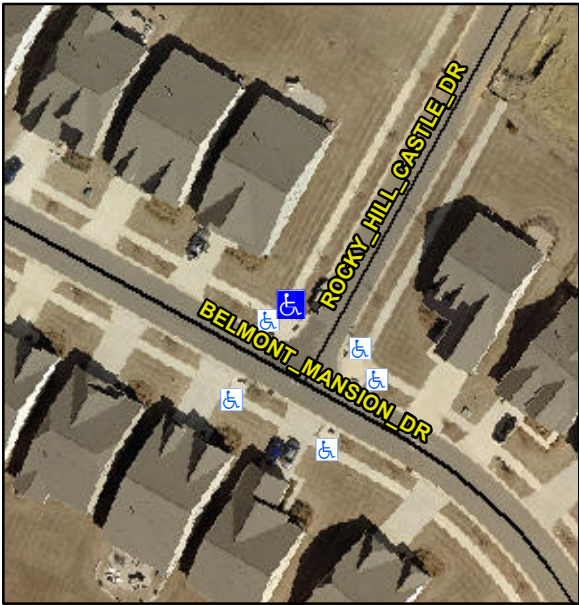
Possible Solutions:		Compliance	Description	Data	Compliance	Description	Data
	Remove & Replace Entire Ramp.		N/A	Ramp Length (in)	100.0	Yes	Ramp Slope (%)	7.8
			Yes	Ramp Width (in)	48.0	No	Ramp XSlope (%)	10.3
			N/A	Flare Type LT	N/A	N/A	Flare Type RT	N/A
			N/A	Flare Slope LT (%)	N/A	N/A	Flare Slope RT (%)	N/A
			N/A	Flare Traversable LT?	N/A	N/A	Flare Traversable RT?	N/A
			N/A	Landing Length (in)	N/A	N/A	DWS Provided?	N/A
			N/A	Landing Width (in)	N/A	N/A	DWS Contrast?	N/A
			N/A	Landing Slope (%)	N/A	N/A	DWS Length (in)	N/A
			N/A	Landing X Slope (%)	N/A	N/A	DWS Full Width?	N/A
Surveyor Notes:	N/A		N/A	Landing Curb? (Y/N)	N/A	N/A	DWS Offset (in)	N/A
			N/A	Shared Landing?	N/A			
			N/A	Gutter Ponding?	N/A	N/A	Gutter Slope (%)	N/A
			N/A	Gutter Lip Ht (in)	1.5	N/A	Gutter X Slope (%)	N/A
			N/A	Painted X Walk1?	No	N/A	Painted X Walk2?	N/A

X Walk 1 Direction	To SE		X Walk 2 Direction	N/A
			N/A	X Walk 1 Width (in)	N/A	N/A	X Walk 2 Width (in)	N/A
				X Walk 1 Slope (%)	0.4		X Walk 2 Slope (%)	N/A
				X Walk 1 X Slope (%)	3.0		X Walk 2 X Slope (%)	N/A
			N/A	Ramp inside XWalk1?	N/A	N/A	Ramp inside XWalk2?	N/A
PROW/ADA:	Not Found, R304.5.3			Road Slope (%)	N/A	N/A	Clear Space?	N/A
				Road X Slope (%)	N/A	N/A	Clear Space to XWalk (in)	N/A
			N/A	Any Obstructions?	N/A	N/A	Storm Grate/Utility Hazard?	N/A
				Obstruction Type			Storm Grate/Utility Type	
					N/A			N/A
						Yes	Surface Condition? (G/P)	Good
	Total Cost:		\$	1850.00
