Access Compliance Report Public Rights-of-Way (Curb Ramps)

Main Street: PARK RD **Cross Street: N/A** Location: Intersection ID: 10033988 NW ADA ID: D2189764A30E Ramp Type: Directional2 Initial Pass/Fail: Fail **Overall Compliance: No Severity Score:** 12.5

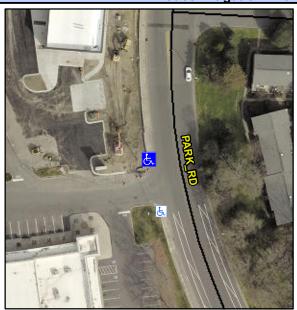
N/A	Ramp Length (in)	78.0	N/A	Grade Break?
Yes	Ramp Width (in)	48.0	N/A	Grade Break Slope (%)
Yes	Ramp Slope (%)	6.2	N/A	Grade Break XSlope (%)
No	Ramp XSlope (%)	5.2		
N/A	Flare Type LT	N/A	N/A	Flare Type RT
N/A	Flare Slope LT (%)	N/A	N/A	Flare Slope RT (%)
N/A	Flare Traversable LT?	N/A	N/A	Flare Traversable RT?
N/A	Landing Length (in)	0.0	N/A	DWS Provided?
N/A	Landing Width (in)	0.0	N/A	DWS Contrast?
N/A	Landing Slope (%)	0.0	N/A	DWS Length (in)
N/A	Landing X Slope (%)	0.0	N/A	DWS Full Width?
N/A	Landing Curb? (Y/N)	N/A	N/A	DWS Offset LT (in)
N/A	Shared Landing?	N/A	N/A	DWS Offset RT (in)
N/A	Gutter Ponding?	0.0	N/A	Gutter Slope (%)
N/A	Gutter Lip Ht (in)	0.0	N/A	Gutter X Slope (%)
N/A	Painted X Walk1?	No		Road Slope (%)
	X Walk 1 Direction	To SE		Road X Slope (%)
	X Walk 1 Width (in)	N/A		Clear Space?
	X Walk 1 Slope (%)	5.0	N/A	Clear Space to XWalk (in)
	X Walk 1 X Slope (%)	6.1	N/A	Storm Grate/Utility Hazard?

N/A	Ramp inside XWalk1?	N/A		Storm Grate/Utility Type
N/A	Any Obstructions?	N/A		
	Obstruction Type		Yes	Surface Condition? (G/P)
		N/A	N/A	Curb Slope (%)

Possible Solutions:					
Remove & Replace Entire Ramp.					
·					
Surveyor Notes:					
N/A					
PROW/ADA:					
R304.5.3
