# Access Compliance Report

## Public Rights-of-Way

### (Curb Ramps)

| Intersection ID: 47850 | Main Street: LAGO_VISTA_CT | Cross Street: SERAPE_RD | Location: SE |

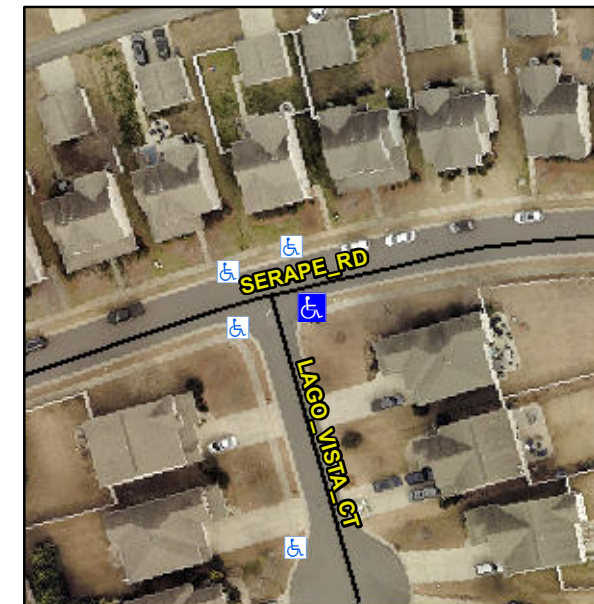
| ADA ID: D2202EB826A0 | Ramp Type: PerpDiag | Initial Pass/Fail: Fail | Overall Compliance: No |
| | | Severity Score: 10 | |

| Compliance | Description | Data | Compliance | Description | Data |
|---|---|---|---|---|---|
| N/A | Ramp Length (in) | 48.5 | Yes | Ramp Slope (%) | 5.9 |
| No | Ramp Width (in) | 42.5 | No | Ramp XSlope (%) | 2.2 |

**Remove & Replace Curb Ramp With Two New Directional Ramps or Equivalent.**

**R304.5.1, R304.5.3**

Total Cost: \$ 3200.00
