Access Compliance Report

Public Rights-of-Way

(Curb Ramps)

Intersection ID: 2846	Main Street: BEITH_CT	Cross Street: TAYMOUTH_LN	Location: SE
ADA ID: D22301B41C6A	Ramp Type: PerpDiag	Initial Pass/Fail: Fail	Overall Compliance: No
Codes/Mitigation Info/Possible Solution			Severity Score: 50
			Field Measurements/Component Compliance

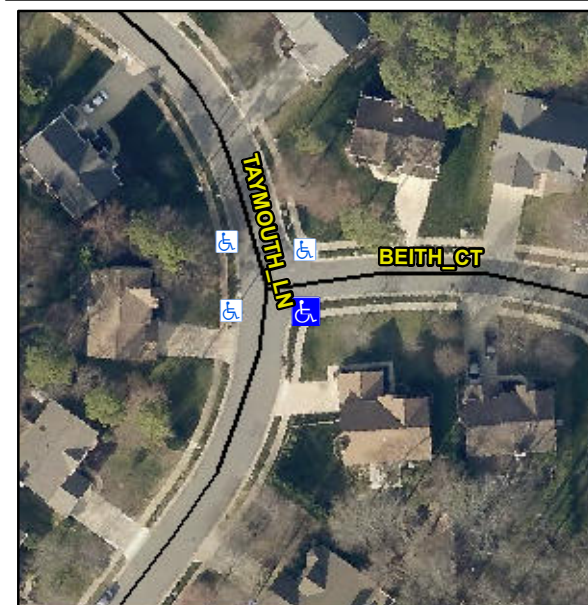
Not Found, R304.2.2, R304.5.3

Compliance	Description	Data	Compliance	Description	Data
N/A	Ramp Length (in)	47.0	No	Ramp Slope (%)	17.4
Yes	Ramp Width (in)	48.0	No	Ramp XSlope (%)	7.6
N/A	Flare Type LT	N/A	N/A	Flare Type RT	N/A
N/A	Flare Slope LT (%)	N/A	N/A	Flare Slope RT (%)	N/A
N/A	Flare Traversable LT?	N/A	N/A	Flare Traversable RT?	N/A
N/A	Landing Length (in)	N/A	N/A	DWS Provided?	N/A
N/A	Landing Width (in)	N/A	N/A	DWS Contrast?	N/A
N/A	Landing Slope (%)	N/A	N/A	DWS Length (in)	N/A
N/A	Landing X Slope (%)	N/A	N/A	DWS Full Width?	N/A
N/A	Landing Curb? (Y/N)	N/A	N/A	DWS Offset (in)	N/A
N/A	Shared Landing?	N/A			
N/A	Gutter Ponding?	N/A	N/A	Gutter Slope (%)	N/A
N/A	Gutter Lip Ht (in)	N/A	N/A	Gutter X Slope (%)	N/A
N/A	Painted X Walk1?	No	N/A	Painted X Walk2?	No
	X Walk 1 Direction	To N		X Walk 2 Direction	To W
N/A	X Walk 1 Width (in)	N/A	N/A	X Walk 2 Width (in)	N/A
	X Walk 1 Slope (%)	0.8		X Walk 2 Slope (%)	5.1
	X Walk 1 X Slope (%)	6.0		X Walk 2 X Slope (%)	0.5

N/A	Ramp inside XWalk1?	N/A	N/A	Ramp inside XWalk2?	N/A
	Road Slope (%)	4.9	N/A	Clear Space?	N/A
	Road X Slope (%)	4.2	N/A	Clear Space to XWalk (in)	N/A
N/A	Any Obstructions?	N/A	N/A	Storm Grate/Utility Hazard?	N/A
	Obstruction Type			Storm Grate/Utility Type	
		N/A			N/A
			Yes	Surface Condition? (G/P)	Good

Possible Solutions:

Remove & Replace Curb Ramp With Two New Directional Ramps or Equivalent.

Total Cost: \$ **3200.00**
