# Access Compliance Report

## Public Rights-of-Way

### (Curb Ramps)

| Intersection ID: 23300 | Main Street: SHARON_RD_WEST | Cross Street: SHARONBROOK_DR | Location: NE |

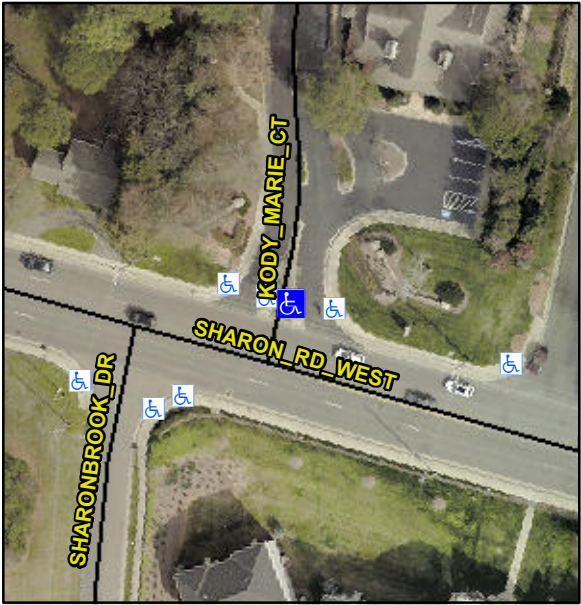
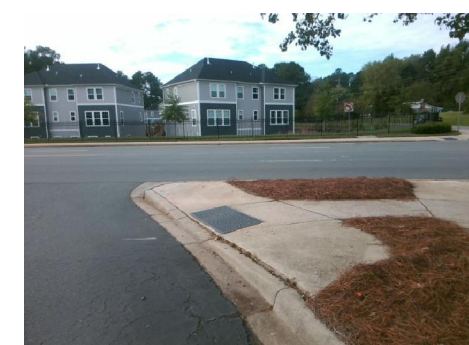
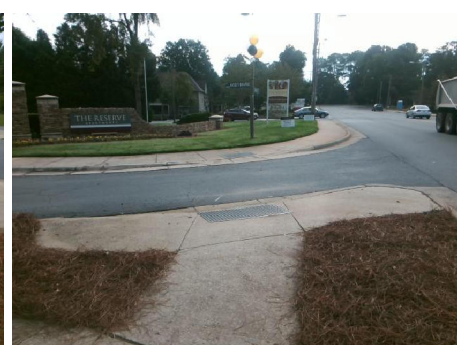
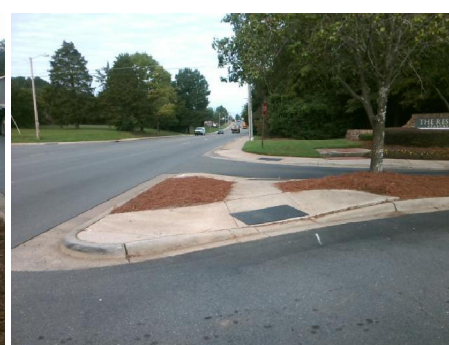
| ADA ID: D22955505FE3 | Ramp Type: Perp | Initial Pass/Fail: Fail | Overall Compliance: No |

| | | | Severity Score: 13.75 |

| Codes/Mitigation Info/Possible Solution | | | Field Measurements/Component Compliance | | |
|---|--|---|---|---|---|
| | <b>Remove &amp; Replace Entire Ramp.</b> | | <b>No</b> | Ramp Length (in) | <b>61.0</b> |
| <p>Surveyor Notes:</p> <p><b>N/A</b></p> <p>PROW/ADA:</p> <p><b>Not Found, R304.2.2, R304.5.3</b></p> | | | <b>N/A</b> | Flare Type RT | <b>N/A</b> |

| Codes/Mitigation Info/Possible Solution | | | Field Measurements/Component Compliance | | |
|---|--|---|---|---|---|
| | Possible Solutions: | | <b>Compliance</b> | <b>Description</b> | <b>Data</b> |
| Total Cost: | | <b>\$ 1850.00</b> | | Obstruction Type | |
