Access Compliance Report Public Rights-of-Way (Curb Ramps)

Intersection ID: 11331 **Cross Street: MEADOW ROSE LN** Location: Main Street: E W T HARRIS BV NW Initial Pass/Fail: Fail **Overall Compliance: No** ADA ID: D2361E94B65D Ramp Type: Combination1 Severity Score: 31.25

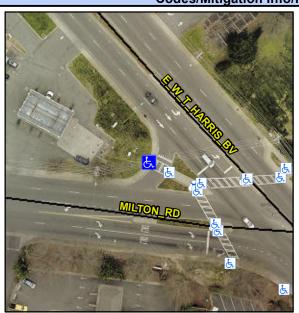
YieldSign Street 1 Name MILTON RD Stop Condition-Street 1 Street 2 Name N/A Stop Condition-Street 2 N/A Possible Solutions: Compliance Description Remove & Replace Entire Ramp. N/A No Yes No N/A Yes Surveyor Notes: N/A N/A PROW/ADA: Not Found, R304.5.1, R304.5.3, R304.3.2
