Access Compliance Report

Public Rights-of-Way

(Curb Ramps)

Intersection ID: 47851	Main Street: CACTUS_VALLEY_RD	Cross Street: SERAPE_RD	Location: SW
ADA ID: D23623EAB819	Ramp Type: PerpDiag	Initial Pass/Fail: Fail	Overall Compliance: No
Severity Score: 8.75			
Codes/Mitigation Info/Possible Solution		Field Measurements/Component Compliance

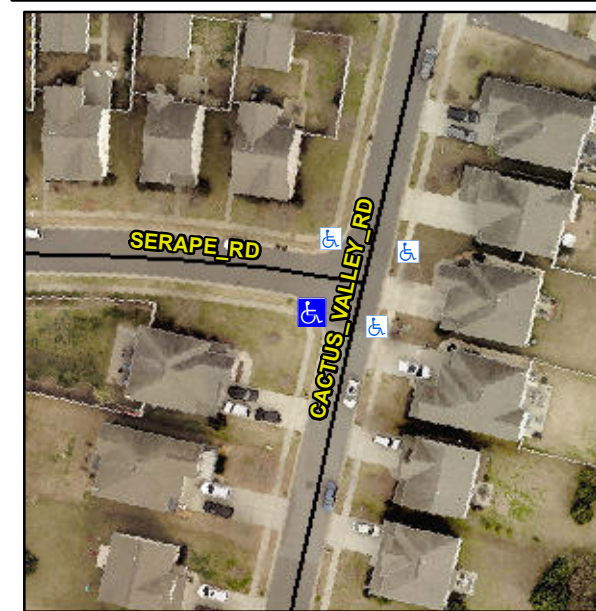
Not Found, R304.5.1

Compliance	Description	Data	Compliance	Description	Data
N/A	Ramp Length (in)	67.0	Yes	Ramp Slope (%)	7.0
No	Ramp Width (in)	44.5	Yes	Ramp XSlope (%)	1.5
N/A	Flare Type LT	N/A	N/A	Flare Type RT	N/A
N/A	Flare Slope LT (%)	N/A	N/A	Flare Slope RT (%)	N/A
N/A	Flare Traversable LT?	N/A	N/A	Flare Traversable RT?	N/A
N/A	Landing Length (in)	N/A	N/A	DWS Provided?	N/A
N/A	Landing Width (in)	N/A	N/A	DWS Contrast?	N/A
N/A	Landing Slope (%)	N/A	N/A	DWS Length (in)	N/A
N/A	Landing X Slope (%)	N/A	N/A	DWS Full Width?	N/A
N/A	Landing Curb? (Y/N)	N/A	N/A	DWS Offset (in)	N/A
N/A	Shared Landing?	N/A			
N/A	Gutter Ponding?	N/A	N/A	Gutter Slope (%)	N/A
N/A	Gutter Lip Ht (in)	N/A	N/A	Gutter X Slope (%)	N/A
N/A	Painted X Walk1?	No	N/A	Painted X Walk2?	No
	X Walk 1 Direction	To SE		X Walk 2 Direction	To NE
N/A	X Walk 1 Width (in)	N/A	N/A	X Walk 2 Width (in)	N/A
	X Walk 1 Slope (%)	1.5		X Walk 2 Slope (%)	1.3
	X Walk 1 X Slope (%)	0.8		X Walk 2 X Slope (%)	0.7

N/A	Ramp inside XWalk1?	N/A	N/A	Ramp inside XWalk2?	N/A
	Road Slope (%)	0.1	N/A	Clear Space?	N/A
	Road X Slope (%)	1.7	N/A	Clear Space to XWalk (in)	N/A
N/A	Any Obstructions?	N/A	N/A	Storm Grate/Utility Hazard?	N/A
	Obstruction Type			Storm Grate/Utility Type	
		N/A			N/A
			Yes	Surface Condition? (G/P)	Good

Possible Solutions:

Remove & Replace Curb Ramp With Two New Directional Ramps or Equivalent.
