Access Compliance Report

Public Rights-of-Way

(Curb Ramps)

Intersection ID: N/A	Main Street: YORK_CENTER	Cross Street: N/A	Location: NE
ADA ID: D238C42C28A9	Ramp Type: Perp	Initial Pass/Fail: Fail	Overall Compliance: No
		Severity Score: 12.5

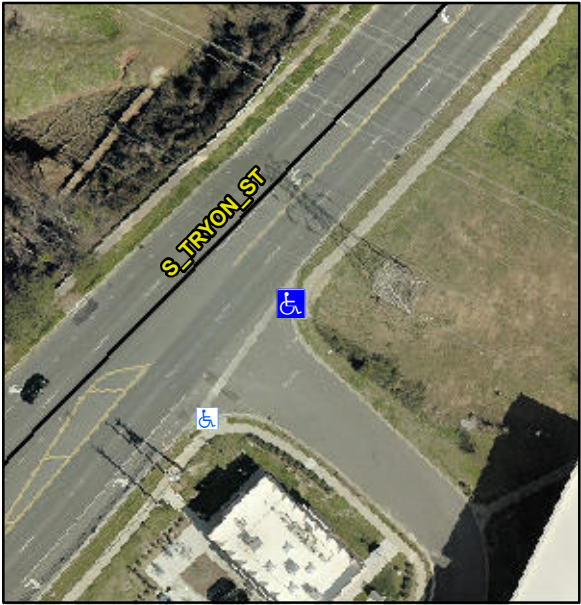
Possible Solutions:		Compliance	Description	Data
	Remove & Replace Entire Ramp.		No	Ramp Length (in)	39.0
			Yes	Ramp Width (in)	48.1
			N/A	Flare Type LT	N/A
			N/A	Flare Slope LT (%)	N/A
			N/A	Flare Traversable LT?	N/A
			N/A	Landing Length (in)	N/A
			N/A	Landing Width (in)	N/A
			N/A	Landing Slope (%)	N/A
			N/A	Landing X Slope (%)	N/A
<p>Surveyor Notes:</p> <p>N/A</p> <p>PROW/ADA:</p> <p>R304.2.2</p>			N/A	Flare Type RT	N/A
			N/A	Flare Slope RT (%)	N/A
			N/A	Flare Traversable RT?	N/A
			N/A	DWS Provided?	N/A
			N/A	DWS Contrast?	N/A
			N/A	DWS Length (in)	N/A
			N/A	DWS Full Width?	N/A
			N/A	DWS Offset (in)	N/A
			N/A	Shared Landing?	N/A
			N/A	Gutter Ponding?	N/A
			N/A	Gutter Lip Ht (in)	N/A
			N/A	Painted X Walk1?	No
				X Walk 1 Direction	To SW
			N/A	X Walk 1 Width (in)	N/A
				X Walk 1 Slope (%)	0.4
				X Walk 1 X Slope (%)	0.3

N/A	Ramp inside XWalk1?	N/A
			N/A	Ramp inside XWalk2?	N/A
			N/A	Road Slope (%)	N/A
			N/A	Road X Slope (%)	N/A
			N/A	Any Obstructions?	N/A
				Obstruction Type	
			N/A	Clear Space?	N/A
			N/A	Clear Space to XWalk (in)	N/A
			N/A	Storm Grate/Utility Hazard?	N/A
				Storm Grate/Utility Type	
			N/A		N/A
			Yes	Surface Condition? (G/P)	Good
