Access Compliance Report Public Rights-of-Way (Curb Ramps)

Intersection ID: 10019556 Main Street: ALMA_BLOUNT_BV Cross Street: N/A Location: SE

ADA ID: D25C8A58F637 Ramp Type: PerpDiag Initial Pass/Fail: Fail Overall Compliance: No Severity Score: 8.75

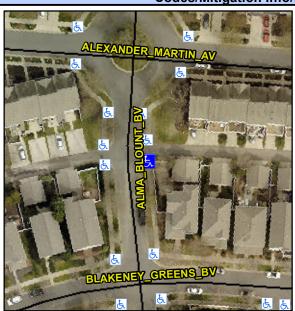
Field Measurements/Component Compliance						
Compl	iance Description	Data	Comp	liance Description	Data	
N/A	Ramp Length (in)	90.0	Yes	Ramp Slope (%)	2.6	
No	Ramp Width (in)	44.0	Yes	Ramp XSlope (%)	1.4	
N/A	Flare Type LT	N/A	N/A	Flare Type RT	N/A	
N/A	Flare Slope LT (%)	N/A	N/A	Flare Slope RT (%)	N/A	
N/A	Flare Traversable LT?	N/A	N/A	Flare Traversable RT?	N/A	
N/A	Landing Length (in)	N/A	N/A	DWS Provided?	N/A	
N/A	Landing Width (in)	N/A	N/A	DWS Contrast?	N/A	
N/A	Landing Slope (%)	N/A	N/A	DWS Length (in)	N/A	
N/A	Landing X Slope (%)	N/A	N/A	DWS Full Width?	N/A	
N/A	Landing Curb? (Y/N)	N/A	N/A	DWS Offset (in)	N/A	
N/A	Shared Landing?	N/A				
N/A	Gutter Ponding?	N/A	N/A	Gutter Slope (%)	N/A	
N/A	Gutter Lip Ht (in)	N/A	N/A	Gutter X Slope (%)	N/A	
N/A	Painted X Walk1?	No	N/A	Painted X Walk2?	No	
	X Walk 1 Direction	To N		X Walk 2 Direction	To W	
N/A	X Walk 1 Width (in)	N/A	N/A	X Walk 2 Width (in)	N/A	
	X Walk 1 Slope (%)	1.6		X Walk 2 Slope (%)	0.1

X Walk 1 X Slope (%)	3.5		X Walk 2 X Slope (%)	0.7	
N/A	Ramp inside XWalk1?	N/A	N/A	Ramp inside XWalk2?	N/A	
	Road Slope (%)	2.4	N/A	Clear Space?	N/A	
	Road X Slope (%)	1.9	N/A	Clear Space to XWalk (in)	N/A	
N/A	Any Obstructions?	N/A	N/A	Storm Grate/Utility Hazard?	N/A	
	Obstruction Type			Storm Grate/Utility Type		
		N/A			N/A	
			Yes	Surface Condition? (G/P)	Good

ossible Solution
Possible Solutions:
Remove & Replace Curb Ramp With Two New Directional Ramps or Equivalent.
Surveyor Notes:
N/A
PROW/ADA:
R304.5.1

PROW/ADA: R304.5.1	
Fotal Cost:	\$ 3200.00
