## Access Compliance Report Public Rights-of-Way (Curb Ramps)

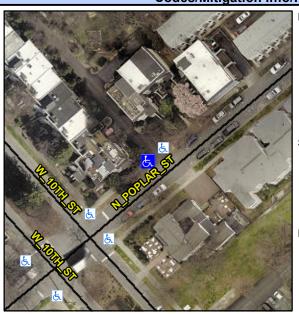
Intersection ID: 10032717Main Street: N\_POPLAR\_STCross Street: N/ALocation: WADA ID: D26C15E2D011Ramp Type: Directional1Initial Pass/Fail: FailOverall Compliance: NoSeverity Score: 13.75

Field Measurements/Component Compliance							
Compl	liance Description	Data	Comp	liance Description	Data		
N/A	Ramp Length (in)	51.0	N/A	Grade Break?	N/A		
Yes	Ramp Width (in)	63.0	N/A	Grade Break Slope (%)	0.0		
No	Ramp Slope (%)	10.8	N/A	Grade Break XSlope (%)	0.0		
No	Ramp XSlope (%)	2.8					
N/A	Flare Type LT	N/A	N/A	Flare Type RT	N/A		
N/A	Flare Slope LT (%)	N/A	N/A	Flare Slope RT (%)	0.0		
N/A	Flare Traversable LT?	N/A	N/A	Flare Traversable RT?	N/A		
N/A	Landing Length (in)	0.0	N/A	DWS Provided?	N/A		
N/A	Landing Width (in)	0.0	N/A	DWS Contrast?	N/A		
N/A	Landing Slope (%)	0.0	N/A	DWS Length (in)	N/A		
N/A	Landing X Slope (%)	0.0	N/A	DWS Full Width?	N/A		
N/A	Landing Curb? (Y/N)	N/A	N/A	DWS Offset LT (in)	N/A		
N/A	Shared Landing?	N/A	N/A	DWS Offset RT (in)	N/A		
N/A	Gutter Ponding?	0.0	N/A	Gutter Slope (%)	N/A		
N/A	Gutter Lip Ht (in)	0.0	N/A	Gutter X Slope (%)	N/A		
N/A	Painted X Walk1?	No		Road Slope (%)	4.7

X Walk 1 Direction	To NE		Road X Slope (%)	1.9		
	X Walk 1 Width (in)	N/A		Clear Space?	N/A		
	X Walk 1 Slope (%)	4.7	N/A	Clear Space to XWalk (in)	N/A		
	X Walk 1 X Slope (%)	1.9	N/A	Storm Grate/Utility Hazard?	N/A		
N/A	Ramp inside XWalk1?	N/A		Storm Grate/Utility Type			
N/A	Any Obstructions?	N/A			N/A		
	Obstruction Type		Yes	Surface Condition? (G/P)	Good		
		N/A	N/A	Curb Slope (%)	3.7

Possible Solution	
Possible Solutions:	Com
Remove & Replace Entire Ramp.	N/A
	Yes
	No
	No
	N/A
	N/A
Surveyor Notes:	N/A
N/A	N/A
	N/A
	N/A
	N/A
PROW/ADA:	N/A
R304.2.2, R304.5.3	N/A
	N/A
	N/A
	N/A
