Access Compliance Report

Public Rights-of-Way

(Curb Ramps)

Intersection ID: 25147	Main Street: CARMEL_ESTATES_RD	Cross Street: REA_RD	Location: SW
ADA ID: D27511F1D80E	Ramp Type: PerpDiag	Initial Pass/Fail: Fail	Overall Compliance: No
		Severity Score: 12.5

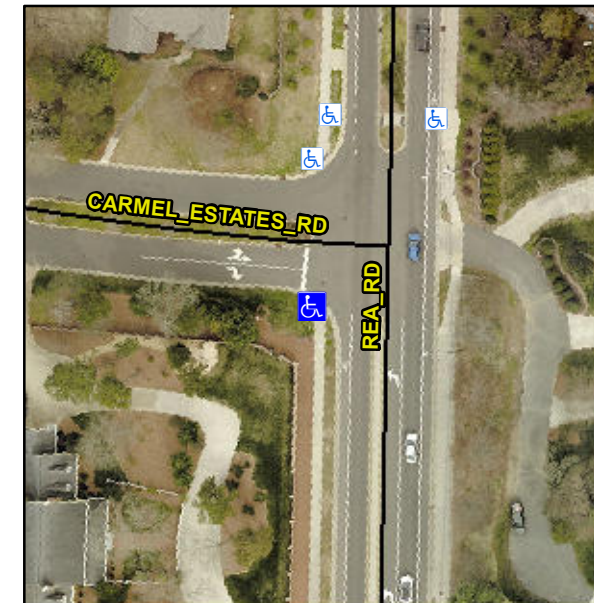
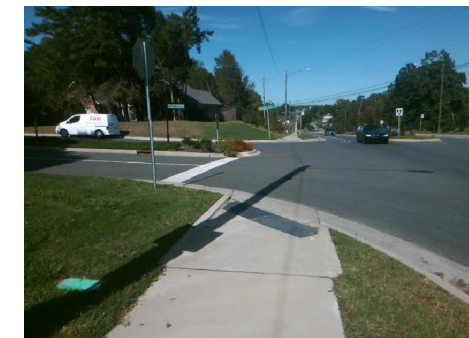
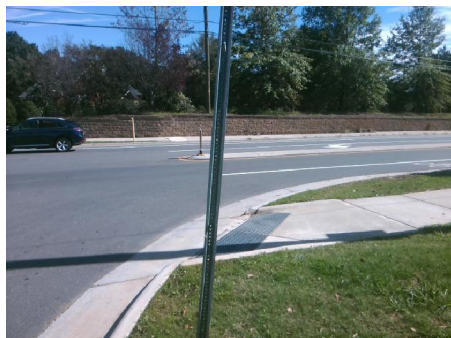
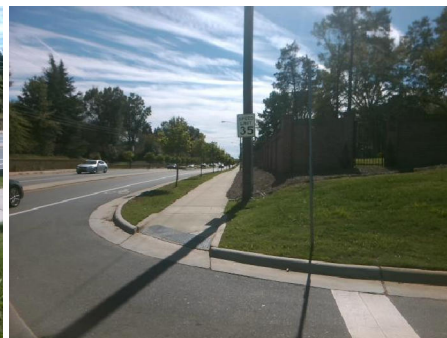
Not Found, R304.2.2

Compliance	Description	Data	Compliance	Description	Data
N/A	Ramp Length (in)	70.0	No	Ramp Slope (%)	9.0
Yes	Ramp Width (in)	89.0	Yes	Ramp XSlope (%)	1.4
N/A	Flare Type LT	N/A	N/A	Flare Type RT	N/A
N/A	Flare Slope LT (%)	N/A	N/A	Flare Slope RT (%)	N/A
N/A	Flare Traversable LT?	N/A	N/A	Flare Traversable RT?	N/A
N/A	Landing Length (in)	N/A	N/A	DWS Provided?	N/A
N/A	Landing Width (in)	N/A	N/A	DWS Contrast?	N/A
N/A	Landing Slope (%)	N/A	N/A	DWS Length (in)	N/A
N/A	Landing X Slope (%)	N/A	N/A	DWS Full Width?	N/A
N/A	Landing Curb? (Y/N)	N/A	N/A	DWS Offset (in)	N/A
N/A	Shared Landing?	N/A			
N/A	Gutter Ponding?	N/A	N/A	Gutter Slope (%)	N/A
N/A	Gutter Lip Ht (in)	N/A	N/A	Gutter X Slope (%)	N/A
N/A	Painted X Walk1?	No	N/A	Painted X Walk2?	No
	X Walk 1 Direction	To E		X Walk 2 Direction	To N
N/A	X Walk 1 Width (in)	N/A	N/A	X Walk 2 Width (in)	N/A
	X Walk 1 Slope (%)	1.4		X Walk 2 Slope (%)	2.7
	X Walk 1 X Slope (%)	2.5		X Walk 2 X Slope (%)	1.7

N/A	Ramp inside XWalk1?	N/A	N/A	Ramp inside XWalk2?	N/A
	Road Slope (%)	0.4	N/A	Clear Space?	N/A
	Road X Slope (%)	3.1	N/A	Clear Space to XWalk (in)	N/A
N/A	Any Obstructions?	N/A	N/A	Storm Grate/Utility Hazard?	N/A
	Obstruction Type			Storm Grate/Utility Type	
		N/A			N/A
			Yes	Surface Condition? (G/P)	Good

Remove & Replace Curb Ramp With Two New Directional Ramps or Equivalent.
