# Access Compliance Report

## Public Rights-of-Way

### (Curb Ramps)

Intersection ID: 53092	Main Street: ALEXANDER_RD	Cross Street: DEERHURST_LN	Location: SE
ADA ID: D27A39F3E5BB	Ramp Type: BlendTrans1	Initial Pass/Fail: Fail	Overall Compliance: No
Severity Score: 21.25			
Codes/Mitigation Info/Possible Solution		Field Measurements/Component Compliance

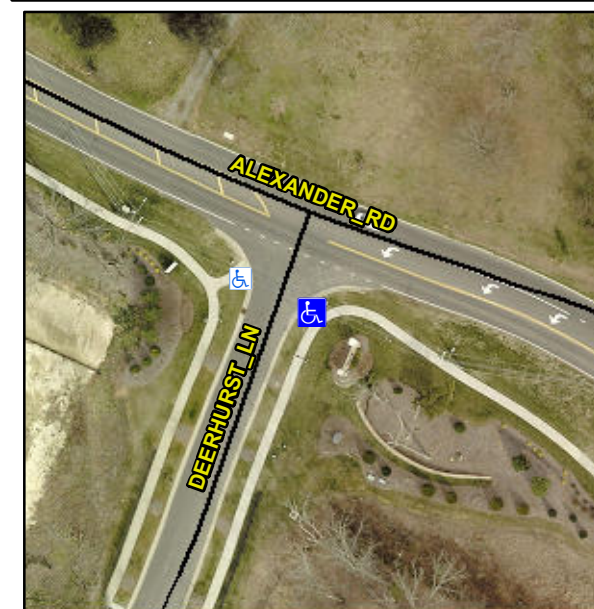
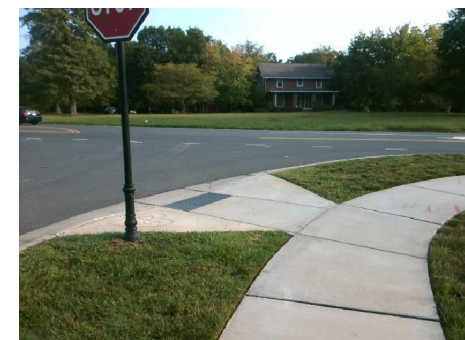
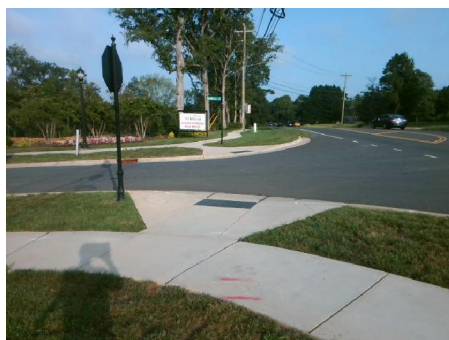
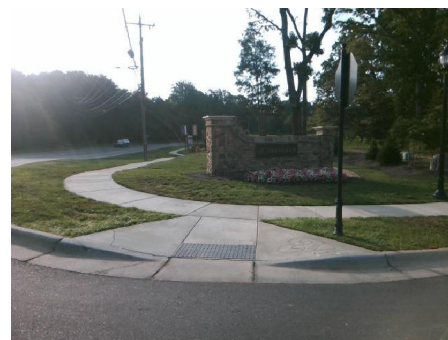
Compliance	Description	Data	Compliance	Description	Data
N/A	Ramp Length (in)	97.0	Yes	BlendTrans Slope (%)	1.3
No	Ramp Width (in)	47.0	No	BlendTrans XSlope (%)	5.3
N/A	Flare Type LT	N/A	N/A	Flare Type RT	N/A
N/A	Flare Slope LT (%)	N/A	N/A	Flare Slope RT (%)	N/A
N/A	Flare Traversable LT?	N/A	N/A	Flare Traversable RT?	N/A
N/A	Landing Length (in)	N/A	N/A	DWS Provided?	N/A
N/A	Landing Width (in)	N/A	N/A	DWS Contrast?	N/A
N/A	Landing Slope (%)	N/A	N/A	DWS Length (in)	N/A
N/A	Landing X Slope (%)	N/A	N/A	DWS Full Width?	N/A
N/A	Landing Curb? (Y/N)	N/A	N/A	DWS Offset (in)	N/A
N/A	Shared Landing?	N/A			
N/A	Gutter Ponding?	N/A	N/A	Gutter Slope (%)	N/A
N/A	Gutter Lip Ht (in)	N/A	N/A	Gutter X Slope (%)	N/A
N/A	Painted X Walk1?	No	N/A	Painted X Walk2?	No
	X Walk 1 Direction	To N		X Walk 2 Direction	To NW
	X Walk 1 Width (in)	N/A		X Walk 2 Width (in)	N/A
	X Walk 1 Slope (%)	6.3		X Walk 2 Slope (%)	2.3
	X Walk 1 X Slope (%)	3.4		X Walk 2 X Slope (%)	3.8

N/A	Ramp inside XWalk1?	N/A	N/A	Ramp inside XWalk2?	N/A
	Road Slope (%)	1.6		Clear Space?	N/A
	Road X Slope (%)	5.2	N/A	Clear Space to XWalk (in)	N/A
N/A	Any Obstructions?	N/A	N/A	Storm Grate/Utility Hazard?	N/A
	Obstruction Type			Storm Grate/Utility Type	
		N/A			N/A
		Yes		Surface Condition? (G/P)	Good
		N/A		Curb Slope (%)	2.8

**Remove & Replace Curb Ramp With Two New Directional Ramps or Equivalent.**

**R304.5.1, R304.5.3**
