Access Compliance Report

Public Rights-of-Way

(Curb Ramps)

Intersection ID: N/A	Main Street: OAK_GLEN_LN	Cross Street: RIDGEMORE_DR	Location: SE
ADA ID: D27ED961B10E	Ramp Type: PerpDiag	Initial Pass/Fail: Fail	Overall Compliance: No
		Severity Score: 12.5

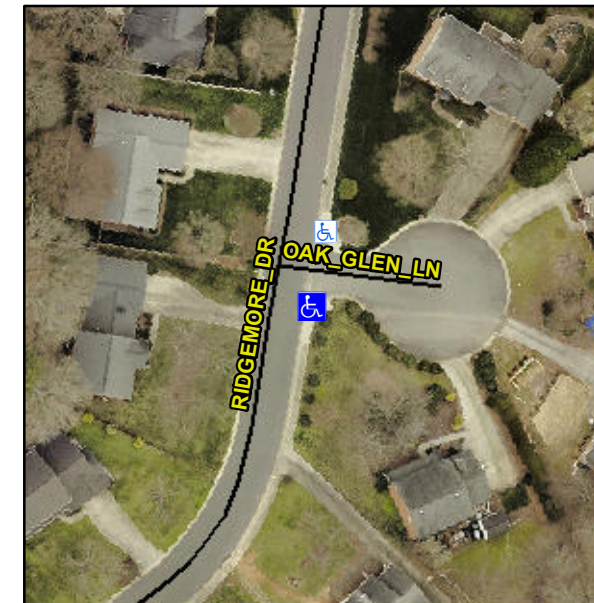
Not Found, R304.5.3

Compliance	Description	Data	Compliance	Description	Data
N/A	Ramp Length (in)	56.0	Yes	Ramp Slope (%)	6.3
Yes	Ramp Width (in)	48.0	No	Ramp XSlope (%)	5.4
N/A	Flare Type LT	N/A	N/A	Flare Type RT	N/A
N/A	Flare Slope LT (%)	N/A	N/A	Flare Slope RT (%)	N/A
N/A	Flare Traversable LT?	N/A	N/A	Flare Traversable RT?	N/A
N/A	Landing Length (in)	N/A	N/A	DWS Provided?	N/A
N/A	Landing Width (in)	N/A	N/A	DWS Contrast?	N/A
N/A	Landing Slope (%)	N/A	N/A	DWS Length (in)	N/A
N/A	Landing X Slope (%)	N/A	N/A	DWS Full Width?	N/A
N/A	Landing Curb? (Y/N)	N/A	N/A	DWS Offset (in)	N/A
N/A	Shared Landing?	N/A			
N/A	Gutter Ponding?	N/A	N/A	Gutter Slope (%)	N/A
N/A	Gutter Lip Ht (in)	N/A	N/A	Gutter X Slope (%)	N/A
N/A	Painted X Walk1?	No	N/A	Painted X Walk2?	No
	X Walk 1 Direction	To N		X Walk 2 Direction	To W
N/A	X Walk 1 Width (in)	N/A	N/A	X Walk 2 Width (in)	N/A
	X Walk 1 Slope (%)	0.2		X Walk 2 Slope (%)	4.1
	X Walk 1 X Slope (%)	5.6		X Walk 2 X Slope (%)	0.3

N/A	Ramp inside XWalk1?	N/A	N/A	Ramp inside XWalk2?	N/A
	Road Slope (%)	4.2	N/A	Clear Space?	N/A
	Road X Slope (%)	3.5	N/A	Clear Space to XWalk (in)	N/A
N/A	Any Obstructions?	N/A	N/A	Storm Grate/Utility Hazard?	N/A
	Obstruction Type			Storm Grate/Utility Type	
		N/A			N/A
		Yes		Surface Condition? (G/P)	Good

Remove & Replace Curb Ramp With Two New Directional Ramps or Equivalent.

Total Cost: \$ 3200.00
