# Access Compliance Report

## Public Rights-of-Way (Curb Ramps)

| Intersection ID: 9814 | Main Street: CLIFTON_ST | Cross Street: PATTON_AV | Location: SE |
| ADA ID: D28B30328609 | Ramp Type: Directional1 | Initial Pass/Fail: Fail | Overall Compliance: No |

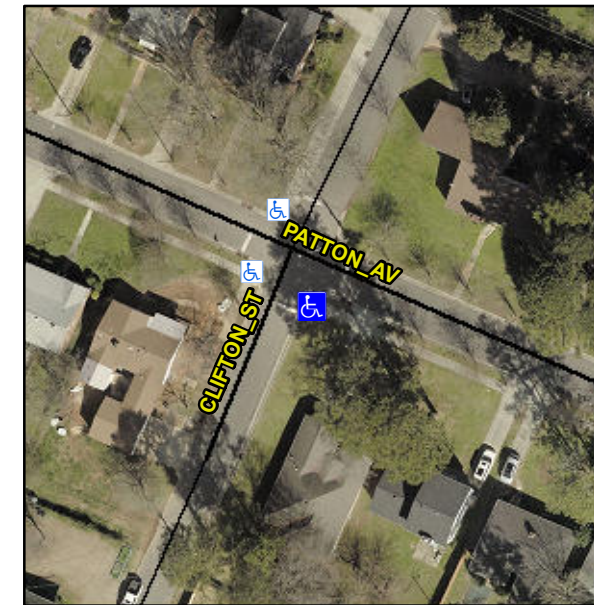
| | | Severity Score: 12.5 | |

**R304.2.2**

| Compliance | Description | Data | Compliance | Description | Data |
|---|---|---|---|---|---|
| No | Ramp Slope (%) | 8.6 | N/A | Grade Break XSlope (%) | 0.0 |

Possible Solutions:

**Remove & Replace Entire Ramp.**
