Access Compliance Report

Public Rights-of-Way

(Curb Ramps)

Intersection ID: 11322	Main Street: N_GRAHAM_ST	Cross Street: W_10TH_ST	Location: S
ADA ID: D28E159C1B3E	Ramp Type: Perp	Initial Pass/Fail: Fail	Overall Compliance: No
Severity Score: 13.75			
Codes/Mitigation Info/Possible Solution		Field Measurements/Component Compliance

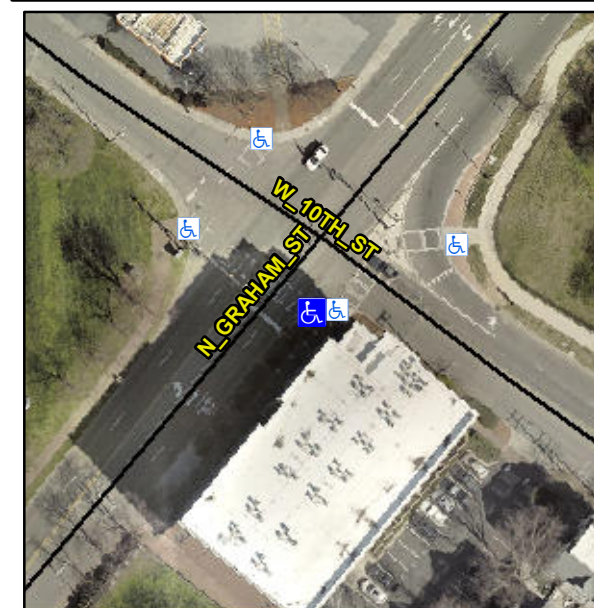
Not Found, R304.2.2, R304.5.3

Compliance	Description	Data	Compliance	Description	Data
N/A	Ramp Length (in)	70.0	No	Ramp Slope (%)	9.0
Yes	Ramp Width (in)	48.0	No	Ramp XSlope (%)	4.8
N/A	Flare Type LT	N/A	N/A	Flare Type RT	N/A
N/A	Flare Slope LT (%)	N/A	N/A	Flare Slope RT (%)	N/A
N/A	Flare Traversable LT?	N/A	N/A	Flare Traversable RT?	N/A
N/A	Landing Length (in)	N/A	N/A	DWS Provided?	N/A
N/A	Landing Width (in)	N/A	N/A	DWS Contrast?	N/A
N/A	Landing Slope (%)	N/A	N/A	DWS Length (in)	N/A
N/A	Landing X Slope (%)	N/A	N/A	DWS Full Width?	N/A
N/A	Landing Curb? (Y/N)	N/A	N/A	DWS Offset (in)	N/A
N/A	Shared Landing?	N/A			
N/A	Gutter Ponding?	N/A	N/A	Gutter Slope (%)	N/A
N/A	Gutter Lip Ht (in)	N/A	N/A	Gutter X Slope (%)	N/A
N/A	Painted X Walk1?	Yes	N/A	Painted X Walk2?	N/A
	X Walk 1 Direction	To NW		X Walk 2 Direction	N/A
N/A	X Walk 1 Width (in)	112.0	N/A	X Walk 2 Width (in)	N/A
	X Walk 1 Slope (%)	2.1		X Walk 2 Slope (%)	N/A
	X Walk 1 X Slope (%)	0.2		X Walk 2 X Slope (%)	N/A

N/A	Ramp inside XWalk1?	Yes	N/A	Ramp inside XWalk2?	N/A
	Road Slope (%)	N/A	N/A	Clear Space?	N/A
	Road X Slope (%)	N/A	N/A	Clear Space to XWalk (in)	N/A
N/A	Any Obstructions?	N/A	N/A	Storm Grate/Utility Hazard?	N/A
	Obstruction Type			Storm Grate/Utility Type	
		N/A			N/A
		Yes		Surface Condition? (G/P)	Good

Possible Solutions:

Remove & Replace Entire Ramp.
