# Access Compliance Report

## Public Rights-of-Way

| Intersection ID: 10527 | Main Street: PARKWAY_AV | Cross Street: TUCKASEEGEE_RD | Location: NE |
| ADA ID: D2A190FBE8DE | Ramp Type: PerpDiag | Initial Pass/Fail: Fail | Overall Compliance: No |

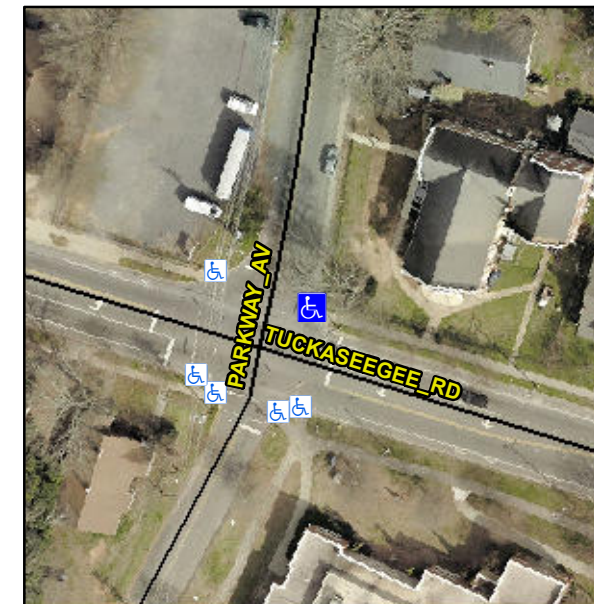
| Severity Score: 8.75 | | | |

**Not Found, R304.5.1**

| Compliance | Description | Data | Compliance | Description | Data |
|---|---|---|---|---|---|
| No | Ramp Width (in) | 47.5 | Yes | Ramp XSlope (%) | 1.4 |

**Remove & Replace Curb Ramp With Two New Directional Ramps or Equivalent.**

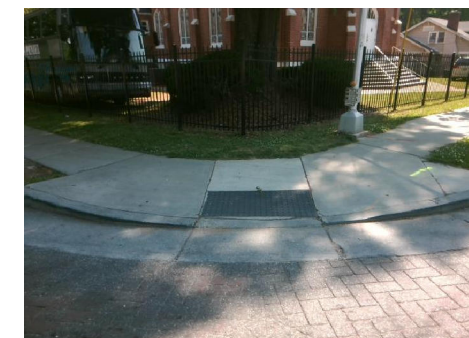
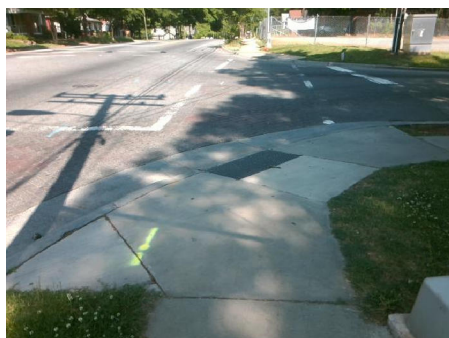
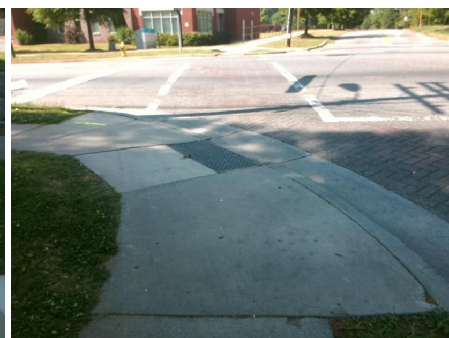
| Compliance | Description | Data | Compliance | Description | Data |
|---|---|---|---|---|---|
| N/A | Ramp Length (in) | 66.5 | Yes | Ramp Slope (%) | 7.4 |
| | | Yes | | Surface Condition? (G/P) | Good |
