Access Compliance Report

Public Rights-of-Way

(Curb Ramps)

Intersection ID: 27041	Main Street: ENDAVEN_LN	Cross Street: ORCHID_HILL_LN	Location: W
ADA ID: D2A6142DE65F	Ramp Type: Para	Initial Pass/Fail: Fail	Overall Compliance: No
Severity Score: 21.25			
Codes/Mitigation Info/Possible Solution		Field Measurements/Component Compliance

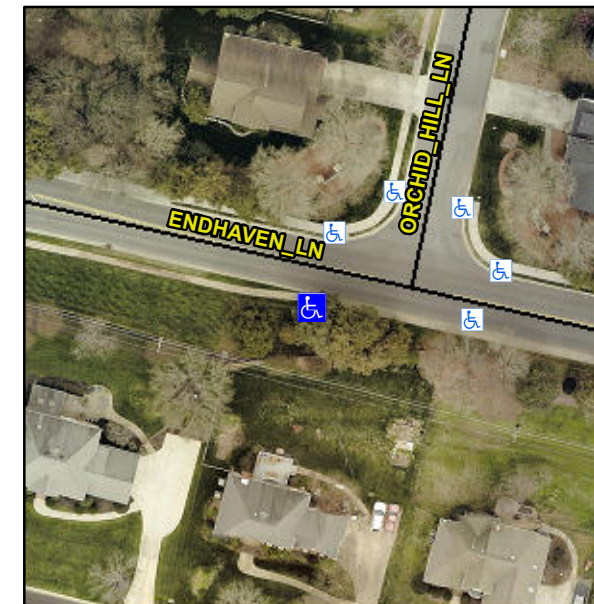
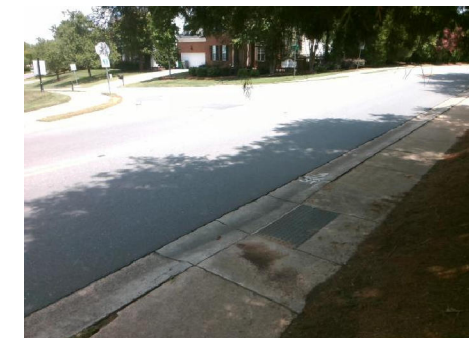
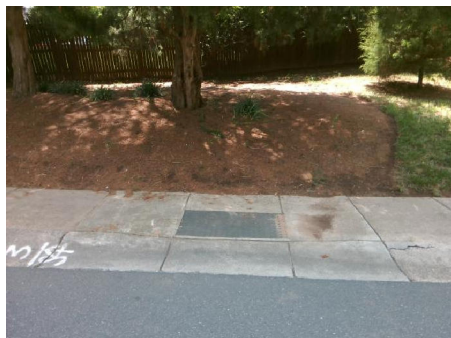
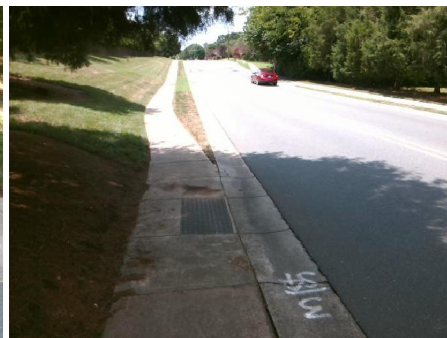
RT RP < 5%

R304.5.1, R304.3.2

Compliance	Description	Data	Compliance	Description	Data
N/A	Ramp Length LT (in)	42.0	N/A	Ramp Length RT (in)	36.0
No	Ramp Width LT (in)	47.0	Yes	Ramp Width RT (in)	48.0
No	Ramp Slope LT (%)	8.6	Yes	Ramp Slope RT (%)	1.3
Yes	Ramp XSlope LT (%)	0.9	Yes	Ramp XSlope RT (%)	0.3
N/A	Landing Length (in)	N/A	N/A	DWS Provided?	N/A
N/A	Landing Width (in)	N/A	N/A	DWS Contrast?	N/A
N/A	Landing Slope (%)	N/A	N/A	DWS Length (in)	N/A
N/A	Landing X Slope (%)	N/A	N/A	DWS Full Width?	N/A
N/A	Landing Curb? (Y/N)	N/A	N/A	DWS Offset (in)	N/A
N/A	Shared Landing?	N/A			
N/A	Gutter Ponding?	N/A	N/A	Gutter Slope (%)	N/A
N/A	Gutter Lip Ht (in)	N/A	N/A	Gutter X Slope (%)	N/A
N/A	Painted X Walk1?	No	N/A	Painted X Walk2?	N/A
	X Walk 1 Direction	To NE		X Walk 2 Direction	N/A
N/A	X Walk 1 Width (in)	N/A	N/A	X Walk 2 Width (in)	N/A
	X Walk 1 Slope (%)	3.4		X Walk 2 Slope (%)	N/A
	X Walk 1 X Slope (%)	5.4		X Walk 2 X Slope (%)	N/A
N/A	Ramp inside XWalk1?	N/A	N/A	Ramp inside XWalk2?	N/A

Road Slope (%)	N/A	N/A	Clear Space?	N/A
	Road X Slope (%)	N/A	N/A	Clear Space to XWalk (in)	N/A
N/A	Any Obstructions?	N/A	N/A	Storm Grate/Utility Hazard?	N/A
	Obstruction Type			Storm Grate/Utility Type	
		N/A			N/A
			Yes	Surface Condition? (G/P)	Good
			N/A	Curb Slope (%)	2.1

Possible Solutions:

Remove & Replace Entire Ramp.
