# Access Compliance Report

## Public Rights-of-Way

### (Curb Ramps)

Intersection ID: 7833	Main Street: FLINTROCK_RD	Cross Street: GLENMOOR_DR	Location:	W
ADA ID: D2AF71AFF334	Ramp Type: Perp	Initial Pass/Fail: Fail	Overall Compliance: No	Severity Score: 10

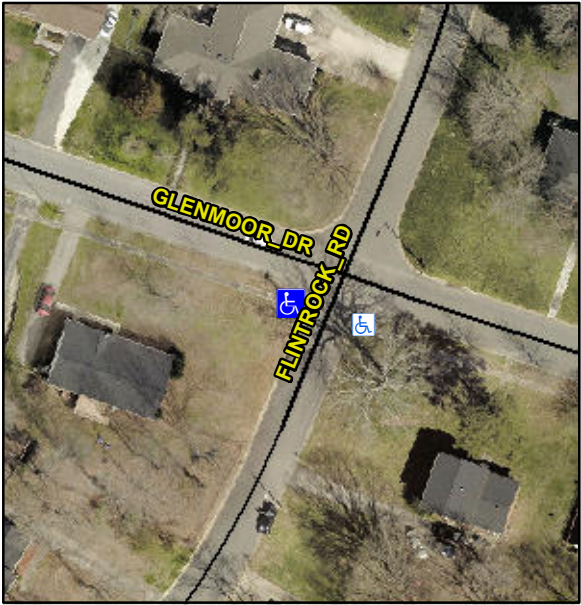
Possible Solutions:		<b>Compliance</b>	<b>Description</b>	<b>Data</b>
	Remove & Replace Entire Ramp.		N/A	Ramp Length (in)	84.0
			No	Ramp Width (in)	41.5
			N/A	Flare Type LT	N/A
			N/A	Flare Slope LT (%)	N/A
			N/A	Flare Traversable LT?	N/A
			N/A	Landing Length (in)	N/A
			N/A	Landing Width (in)	N/A
			N/A	Landing Slope (%)	N/A
			N/A	Landing X Slope (%)	N/A
<p>Surveyor Notes:</p> <p>N/A</p> <p>PROW/ADA:</p> <p>Not Found, R304.5.1</p>			N/A	Flare Type RT	N/A
			N/A	Flare Slope RT (%)	N/A
			N/A	Flare Traversable RT?	N/A
			N/A	DWS Provided?	N/A
			N/A	DWS Contrast?	N/A
			N/A	DWS Length (in)	N/A
			N/A	DWS Full Width?	N/A
			N/A	DWS Offset (in)	N/A
			N/A	Shared Landing?	N/A
			N/A	Gutter Ponding?	N/A
			N/A	Gutter Lip Ht (in)	0.5
			N/A	Painted X Walk1?	No
				X Walk 1 Direction	To SE
			N/A	X Walk 1 Width (in)	N/A
				X Walk 1 Slope (%)	2.0

X Walk 1 X Slope (%)	5.7
			N/A	Ramp inside XWalk1?	N/A
				Road Slope (%)	N/A
				Road X Slope (%)	N/A
			N/A	Any Obstructions?	N/A
				Obstruction Type	
Total Cost:		\$ 1850.00			
			N/A		N/A
			Yes	Surface Condition? (G/P)	Good
