Access Compliance Report

Public Rights-of-Way

(Curb Ramps)

Intersection ID: 5117	Main Street: SPECTOR_DR	Cross Street: STATESVILLE_RD	Location:	W
ADA ID: D2B2232D6419	Ramp Type: Combination1	Initial Pass/Fail: Fail	Overall Compliance: No	Severity Score: 10

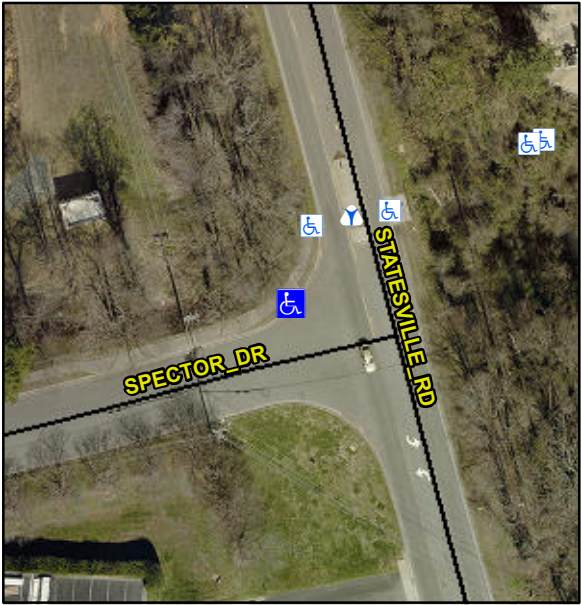
Possible Solutions:		Compliance	Description	Data
	Remove & Replace Entire Ramp.		N/A	Ramp Length LT (in)	55.5
			Yes	Ramp Width LT (in)	61.0
			Yes	Ramp Slope LT (%)	3.3
			No	Ramp XSlope LT (%)	2.5
			N/A	Ramp Length (in)	47.0
			No	Ramp Width (in)	47.5
			N/A	Flare Type LT	N/A
			N/A	Flare Slope LT (%)	N/A
			N/A	Flare Traversable LT?	N/A
<p>Surveyor Notes:</p> <p>LT RP < 5%, RT RP < 5%</p> <p>PROW/ADA:</p> <p>R304.5.1, R304.5.3</p>			N/A	Landing Length (in)	N/A
			N/A	Landing Width (in)	N/A
			N/A	Landing Slope (%)	N/A
			N/A	Landing X Slope (%)	N/A
			N/A	Landing Curb? (Y/N)	N/A
			N/A	Shared Landing?	N/A
			N/A	Gutter Ponding?	N/A
			N/A	Gutter Lip Ht (in)	N/A
			N/A	Painted X Walk1?	No
				X Walk 1 Direction	To S
<p>Street 1 Name</p> <p>Stop Condition-Street 1</p> <p>Street 2 Name</p> <p>Stop Condition-Street 2</p>			N/A	X Walk 1 Width (in)	N/A

X Walk 1 Slope (%)	7.6
				X Walk 1 X Slope (%)	1.6
			N/A	Ramp inside XWalk1?	N/A
				Road Slope (%)	N/A
				Road X Slope (%)	N/A
			N/A	Ramp inside XWalk2?	N/A
				Clear Space?	N/A
			N/A	Clear Space to XWalk (in)	N/A
			N/A	Any Obstruction?	N/A

Obstruction Type	N/A
					N/A
			N/A	Storm Grate/Utility Hazard?	N/A
				Storm Grate/Utility Type	N/A
					N/A
			Yes	Surface Condition? (G/P)	Good
				Curb Slope (%)	N/A
					N/A
					N/A
					N/A
Total Cost:		\$ 1800.00	N/A
