Access Compliance Report

Public Rights-of-Way

(Curb Ramps)

Intersection ID: 32007	Main Street: E WESTINGHOUSE BV	Cross Street: OLD NATIONS FORD RD	Location: NE
ADA ID: D2C2053242E3	Ramp Type: PerpDiag	Initial Pass/Fail: Fail	Overall Compliance: No
Severity Score: 12.5			
Codes/Mitigation Info/Possible Solution		Field Measurements/Component Compliance

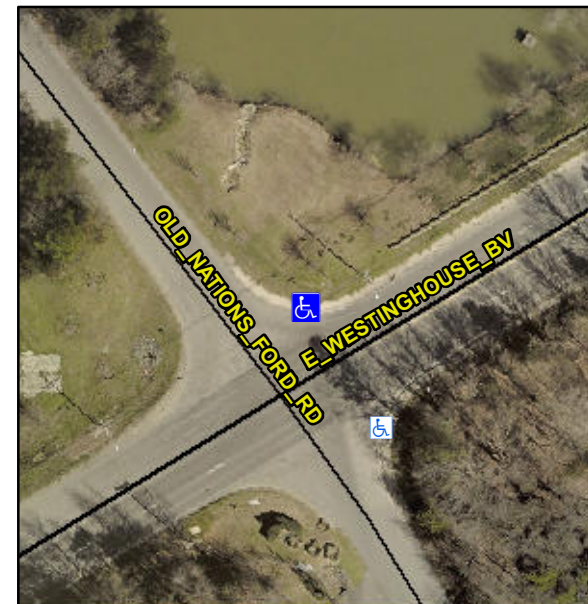
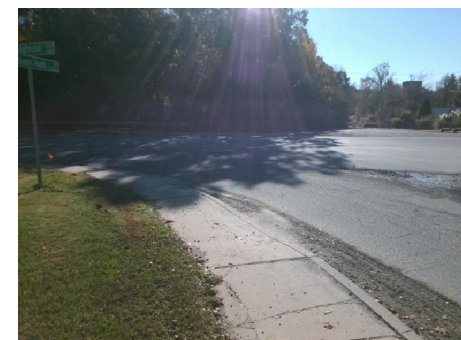
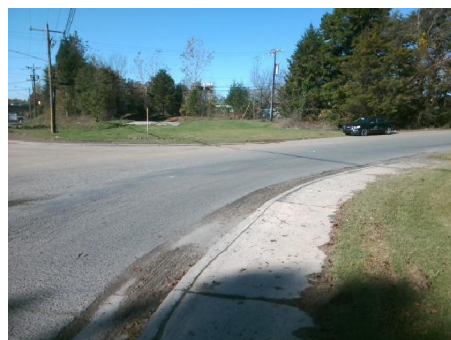
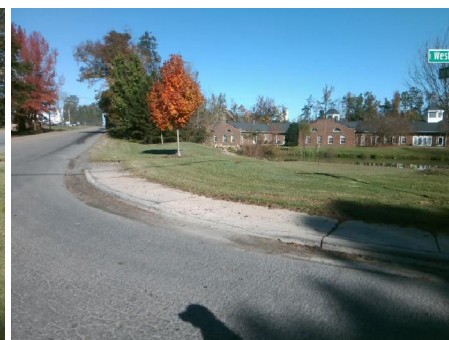
Not Found, R304.2.2

Compliance	Description	Data	Compliance	Description	Data
N/A	Ramp Length (in)	52.0	No	Ramp Slope (%)	10.0
Yes	Ramp Width (in)	48.0	Yes	Ramp XSlope (%)	1.1
N/A	Flare Type LT	N/A	N/A	Flare Type RT	N/A
N/A	Flare Slope LT (%)	N/A	N/A	Flare Slope RT (%)	N/A
N/A	Flare Traversable LT?	N/A	N/A	Flare Traversable RT?	N/A
N/A	Landing Length (in)	N/A	N/A	DWS Provided?	N/A
N/A	Landing Width (in)	N/A	N/A	DWS Contrast?	N/A
N/A	Landing Slope (%)	N/A	N/A	DWS Length (in)	N/A
N/A	Landing X Slope (%)	N/A	N/A	DWS Full Width?	N/A
N/A	Landing Curb? (Y/N)	N/A	N/A	DWS Offset (in)	N/A
N/A	Shared Landing?	N/A			
N/A	Gutter Ponding?	N/A	N/A	Gutter Slope (%)	N/A
N/A	Gutter Lip Ht (in)	N/A	N/A	Gutter X Slope (%)	N/A
N/A	Painted X Walk1?	No	N/A	Painted X Walk2?	No
	X Walk 1 Direction	To SW		X Walk 2 Direction	To SE
N/A	X Walk 1 Width (in)	N/A	N/A	X Walk 2 Width (in)	N/A
	X Walk 1 Slope (%)	0.8		X Walk 2 Slope (%)	1.5
	X Walk 1 X Slope (%)	2.1		X Walk 2 X Slope (%)	0.3

N/A	Ramp inside XWalk1?	N/A	N/A	Ramp inside XWalk2?	N/A
	Road Slope (%)	1.4	N/A	Clear Space?	N/A
	Road X Slope (%)	1.3	N/A	Clear Space to XWalk (in)	N/A
N/A	Any Obstructions?	N/A	N/A	Storm Grate/Utility Hazard?	N/A
	Obstruction Type			Storm Grate/Utility Type	
		N/A			N/A
			Yes	Surface Condition? (G/P)	Good

Remove & Replace Curb Ramp With Two New Directional Ramps or Equivalent.

Total Cost: \$ 3200.00
