# Access Compliance Report

## Public Rights-of-Way

### (Curb Ramps)

Intersection ID: 45280	Main Street: LAKEHILL_RD	Cross Street: VALLEY_RIDGE_RD	Location: SE
ADA ID: D2C33EEE8770	Ramp Type: PerpDiag	Initial Pass/Fail: Fail	Overall Compliance: No
			Severity Score: 46.25

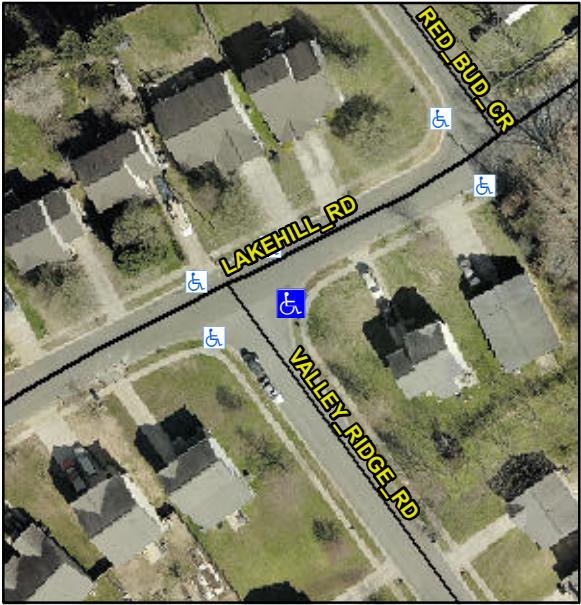
Possible Solutions:		<b>Compliance</b>	<b>Description</b>	<b>Data</b>
	<b>Remove &amp; Replace Curb Ramp With Two New Directional Ramps or Equivalent.</b>		<b>No</b>	Ramp Length (in)	<b>48.0</b>
			<b>No</b>	Ramp Width (in)	<b>41.0</b>
			<b>N/A</b>	Flare Type LT	<b>N/A</b>
			<b>N/A</b>	Flare Slope LT (%)	<b>N/A</b>
			<b>N/A</b>	Flare Traversable LT?	<b>N/A</b>
			<b>N/A</b>	Landing Length (in)	<b>N/A</b>
			<b>N/A</b>	Landing Width (in)	<b>N/A</b>
			<b>N/A</b>	Landing Slope (%)	<b>N/A</b>
			<b>N/A</b>	Landing X Slope (%)	<b>N/A</b>
<p>Surveyor Notes:</p> <p><b>N/A</b></p> <p>PROW/ADA:</p> <p><b>Not Found, R304.5.1, R304.2.2, R304.5.3</b></p>			<b>N/A</b>	Flare Type RT	<b>N/A</b>
			<b>N/A</b>	Flare Slope RT (%)	<b>N/A</b>
			<b>N/A</b>	Flare Traversable RT?	<b>N/A</b>
			<b>N/A</b>	DWS Provided?	<b>N/A</b>
			<b>N/A</b>	DWS Contrast?	<b>N/A</b>

<b>N/A</b>	DWS Length (in)	<b>N/A</b>
			<b>N/A</b>	DWS Full Width?	<b>N/A</b>
			<b>N/A</b>	DWS Offset (in)	<b>N/A</b>
			<b>N/A</b>	Gutter Ponding?	<b>N/A</b>
			<b>N/A</b>	Gutter Lip Ht (in)	<b>N/A</b>
			<b>No</b>	Painted X Walk1?	<b>No</b>
				X Walk 1 Direction	<b>To N</b>
			<b>N/A</b>	X Walk 1 Width (in)	<b>N/A</b>
			<b>4.6</b>	X Walk 1 Slope (%)	<b>4.2</b>
			<b>4.1</b>	X Walk 1 X Slope (%)	<b>8.8</b>
			<b>N/A</b>	Ramp inside XWalk1?	<b>N/A</b>
			<b>7.5</b>	Road Slope (%)	<b>N/A</b>
			<b>3.6</b>	Road X Slope (%)	<b>N/A</b>
			<b>N/A</b>	Any Obstructions?	<b>N/A</b>
				Obstruction Type	
Total Cost: \$ 3200.00			<b>N/A</b>	Storm Grate/Utility Hazard?	<b>N/A</b>
			<b>N/A</b>	Storm Grate/Utility Type	
			<b>N/A</b>	Surface Condition? (G/P)	<b>Good</b>
