## **Access Compliance Report Public Rights-of-Way** (Curb Ramps)

Main Street: LAUDER\_CT Intersection ID: 10030174 Cross Street: N/A Location: NE **Overall Compliance: No** ADA ID: D2C4740D07E9 Ramp Type: Perp Initial Pass/Fail: Fail Severity Score: 21.25

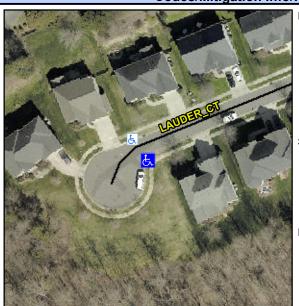
Field Measurements/Component Compliance								
Compl	liance Description	Data	Compl	iance	Description	Data		
N/A	Ramp Length (in)	48.0	Yes	Ramp	Slope (%)	5.5		
No	Ramp Width (in)	45.5	No	Ramp	XSlope (%)	5.8		
N/A	Flare Type LT	N/A	N/A	Flare	Type RT	N/A		
N/A	Flare Slope LT (%)	N/A	N/A	Flare	Slope RT (%)	N/A		
N/A	Flare Traversable LT?	N/A	N/A	Flare	Traversable RT?	N/A		
N/A	Landing Length (in)	N/A	N/A	DWS	Provided?	N/A		
N/A	Landing Width (in)	N/A	N/A	DWS	Contrast?	N/A		
N/A	Landing Slope (%)	N/A	N/A	DWS	Length (in)	N/A		
N/A	Landing X Slope (%)	N/A	N/A	DWS	Full Width?	N/A		
N/A	Landing Curb? (Y/N)	N/A	N/A	DWS	Offset (in)	N/A		
N/A	Shared Landing?	N/A						
N/A	Gutter Ponding?	N/A	N/A	Gutte	r Slope (%)	N/A		
N/A	Gutter Lip Ht (in)	N/A	N/A	Gutte	r X Slope (%)	N/A		
N/A	Painted X Walk1?	No	N/A	Paint	ed X Walk2?	N/A		
	X Walk 1 Direction	To NW		X Wa	lk 2 Direction	N/A		
N/A	X Walk 1 Width (in)	N/A	N/A	X Wa	lk 2 Width (in)	N/A

X Walk 1 Slope (%)	2.9		X Wa	lk 2 Slope (%)	N/A		
	X Walk 1 X Slope (%)	4.5		X Wa	lk 2 X Slope (%)	N/A		
N/A	Ramp inside XWalk1?	N/A	N/A	Ramp	inside XWalk2?	N/A		
	Road Slope (%)	N/A	N/A	Clear	Space?	N/A		
	Road X Slope (%)	N/A	N/A	Clear	Space to XWalk (in)	N/A		
N/A	Any Obstructions?	N/A	N/A	Storm	Grate/Utility Hazard?	N/A		
	Obstruction Type			Storm	Grate/Utility Type			
		N/A				N/A		
			Yes	Surfa	ce Condition? (G/P)	Good

Possible Solution	
Possible Solutions:	Co
Remove & Replace Entire Ramp.	N/
	No
	N/
	N/
9	N/
	N/
Surveyor Notes:	N/
N/A	N/
	N/
	N/
	N/
PROW/ADA:	N/
Not Found, R304.5.1, R304.5.3	N/
	N/
	N/
	N/
